**BREAK and ENTRY PERFORMANCE TEST REPORT**

**Report No.:** D5857.01-201-42

3M COMPANY  
St. Paul, Minnesota

**PRODUCT TYPE:** Safety and Security Window Film

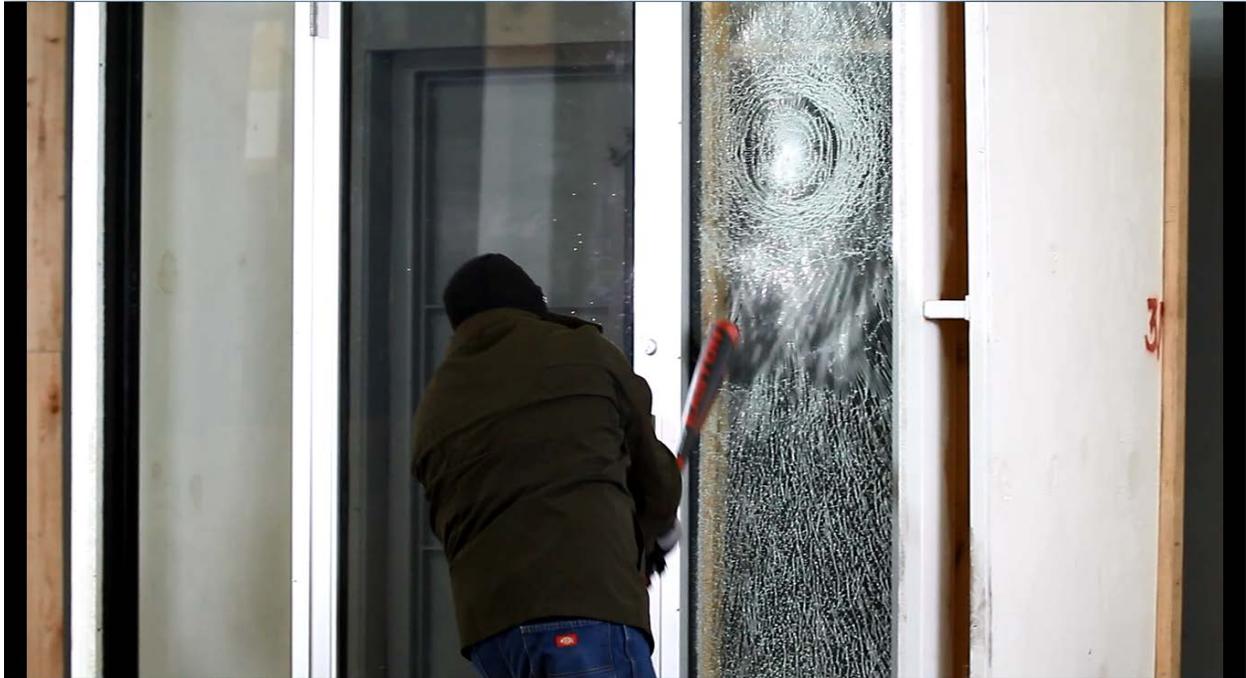
**Photo No. 1**

**Test #1: Bat attack, 3M Scotchshield Ultra 800 (interior) with Safety S70 Exterior (exterior).**

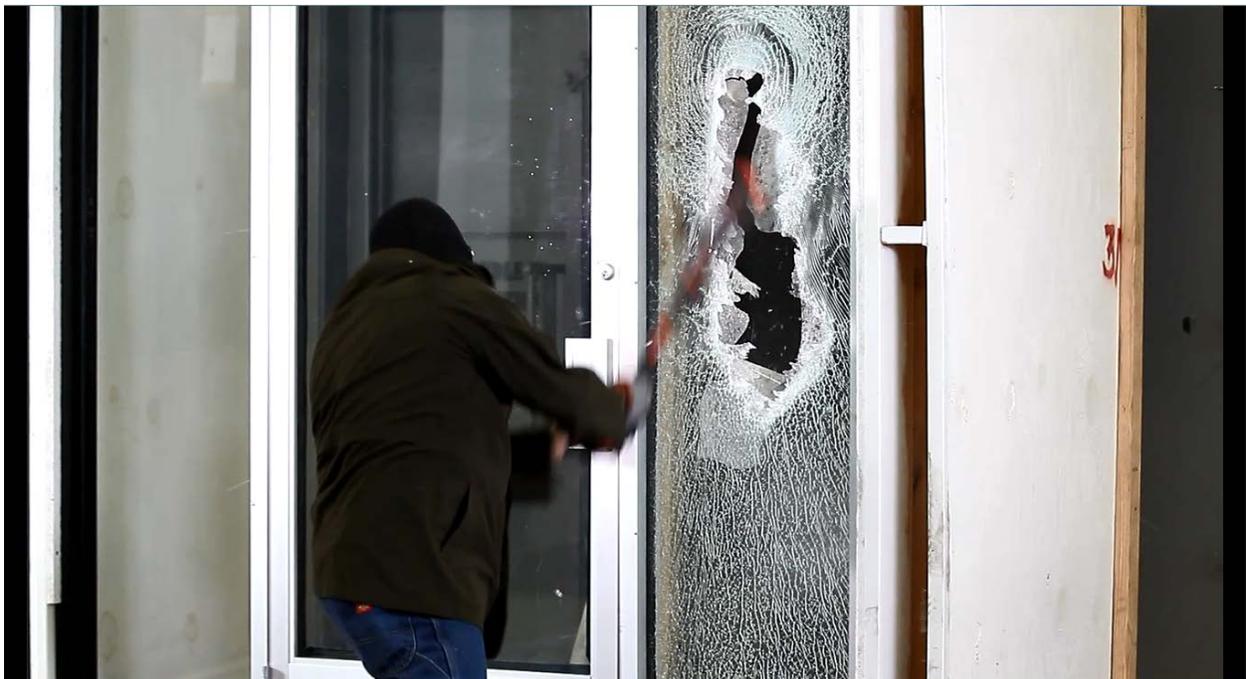
**Photo No. 2**

**Test #1: Bat attack, after several impacts.**

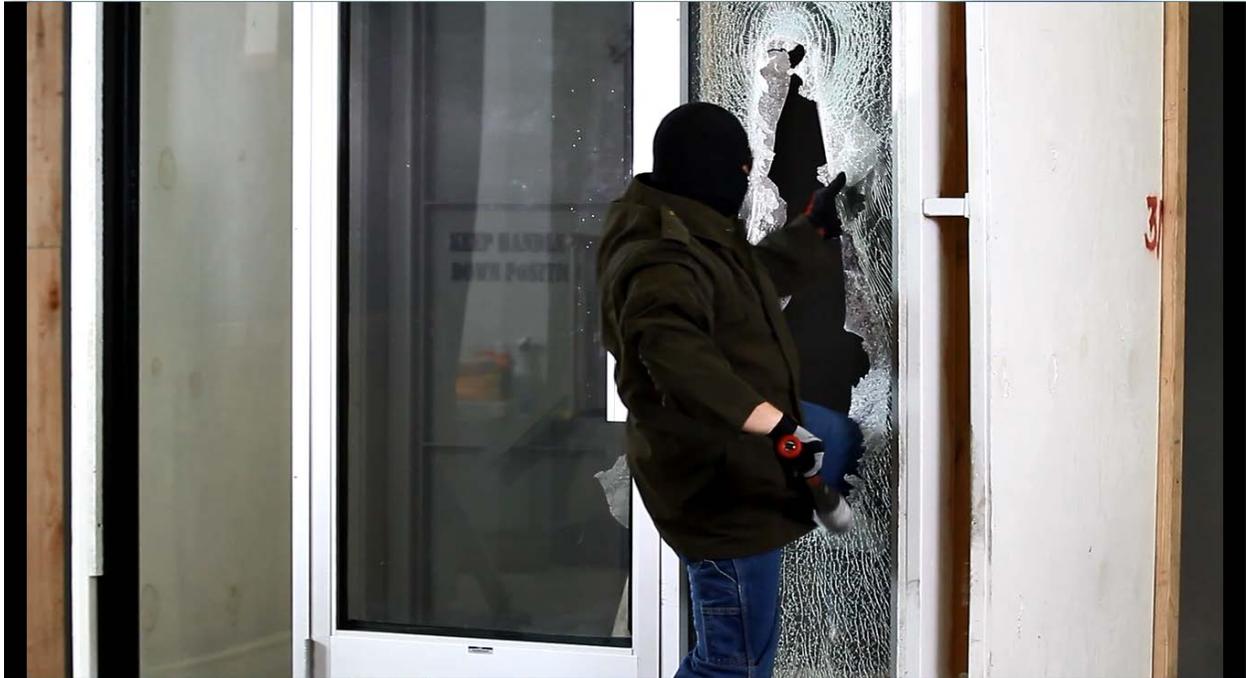
**Photo No. 3**

**5.6 Result:** A total of 30 seconds elapsed before the attacker was able to gain access through door entryway system

**Test #1: Bat attack, accessed gained after 37 impacts and 30 seconds.**

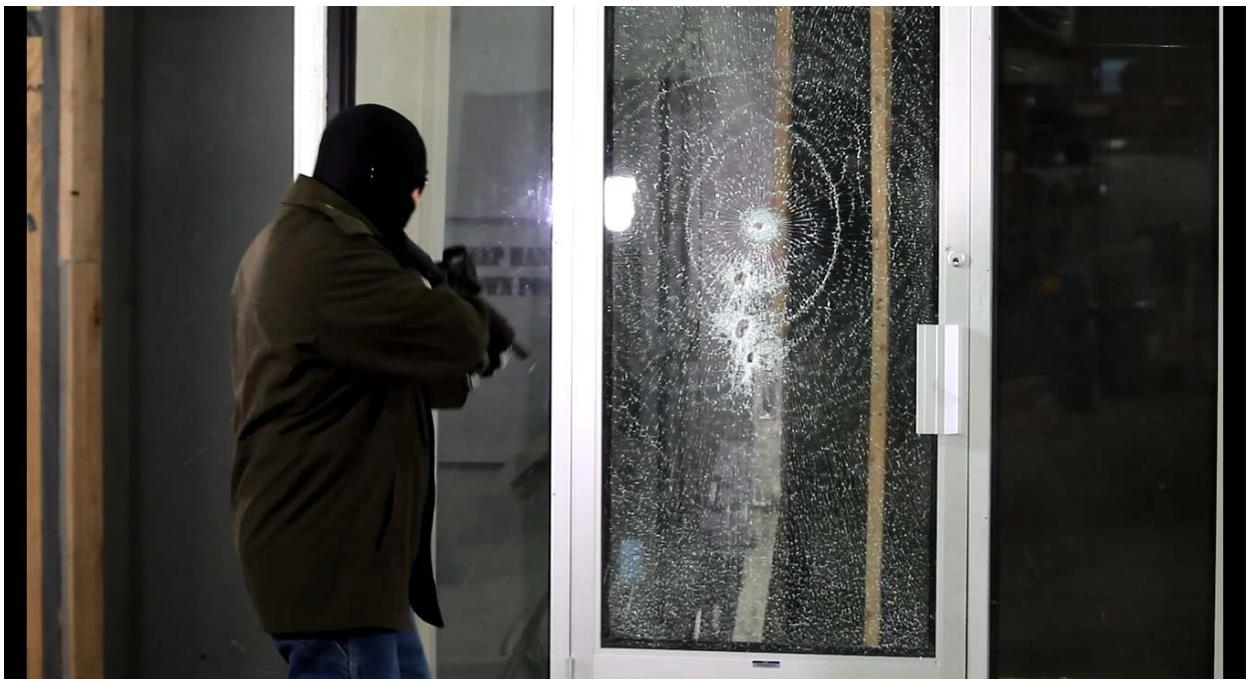
**Photo No. 4**

**Test #2: 3M Scotchshield 800, Semi-automatic rifle attack, after 4 shots.**

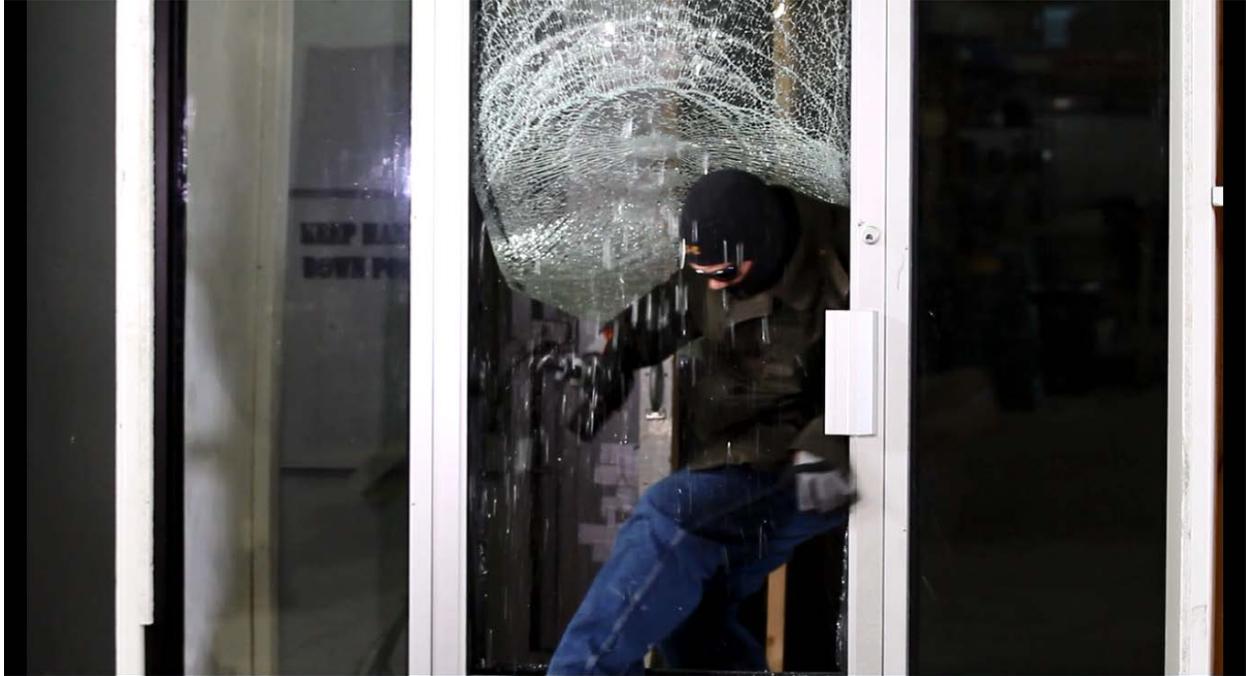
**Photo No. 5**

*Note 4: Attachment system failed before film penetration. Not enough time allowed for attachment system adhesive bond to cure.*

**Test #2: Semi-automatic rifle attack, accessed gained after 33 impacts and 35 seconds.**

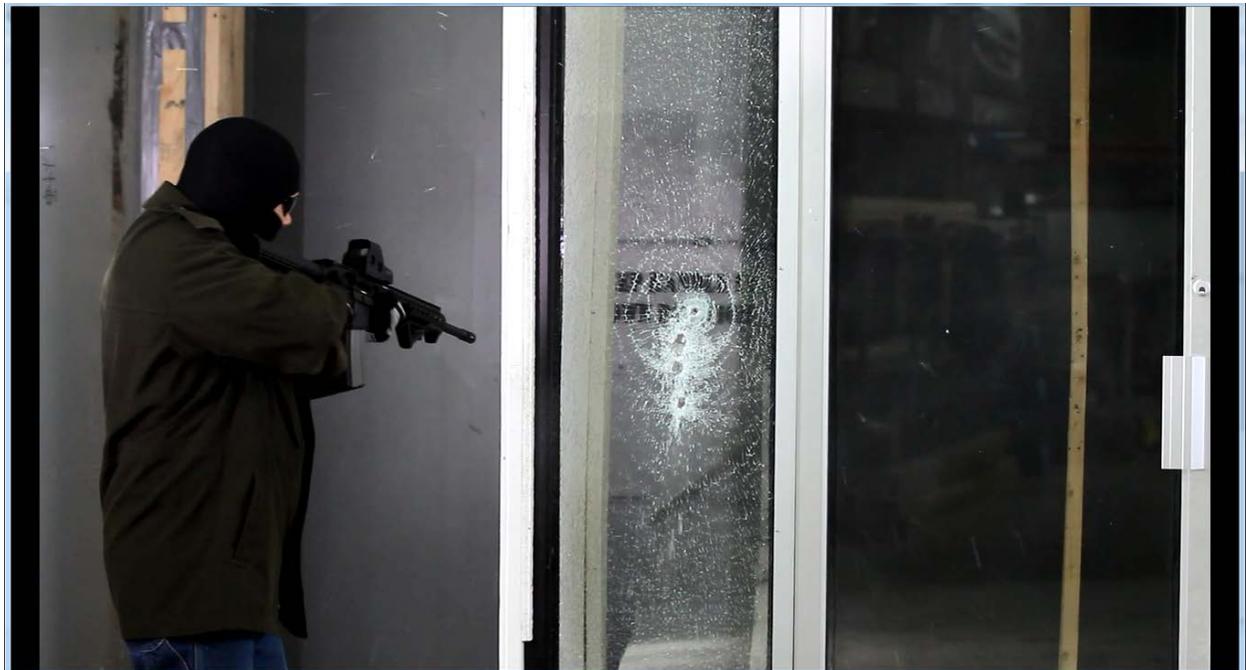
**Photo No. 6**

**Test #3: 3M Safety S80, Semi-automatic rifle attack, after 4 shots.**

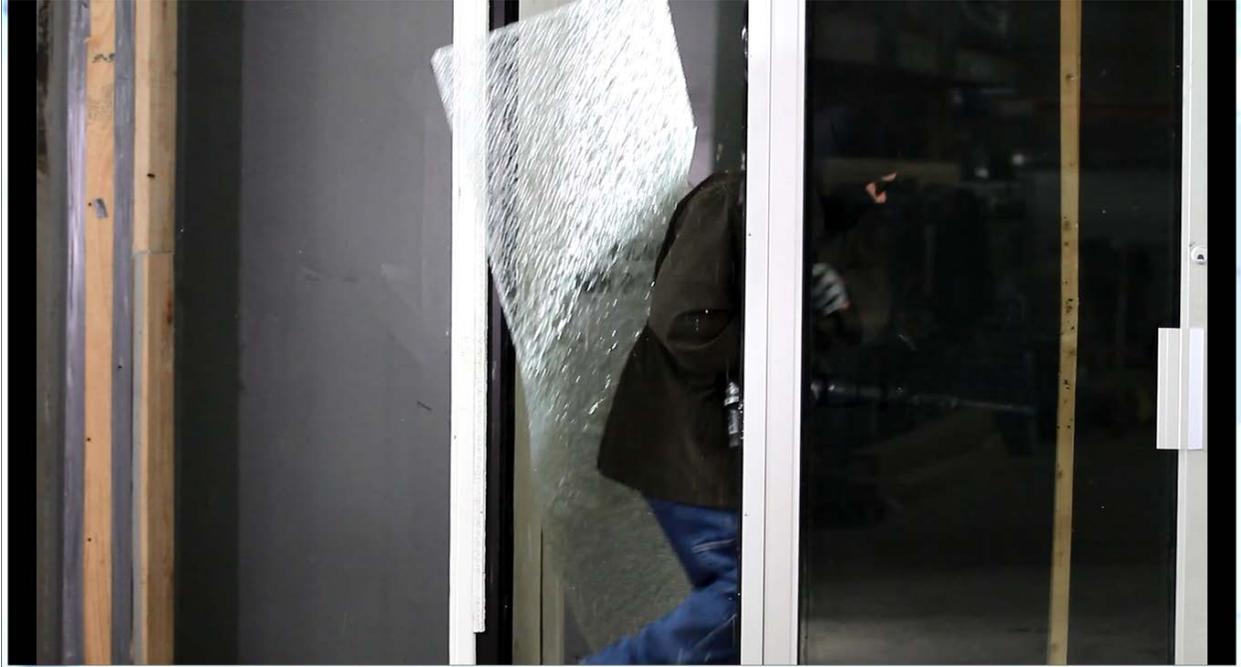
**Photo No. 7**

*Note 4: Attachment system failed before film penetration. Failure of attachment system adhesion to film. Not enough time allowed for attachment system adhesive bond to cure.*

**Test #3: Semi-automatic rifle attack, accessed gained after 27 impacts and 27 seconds.**

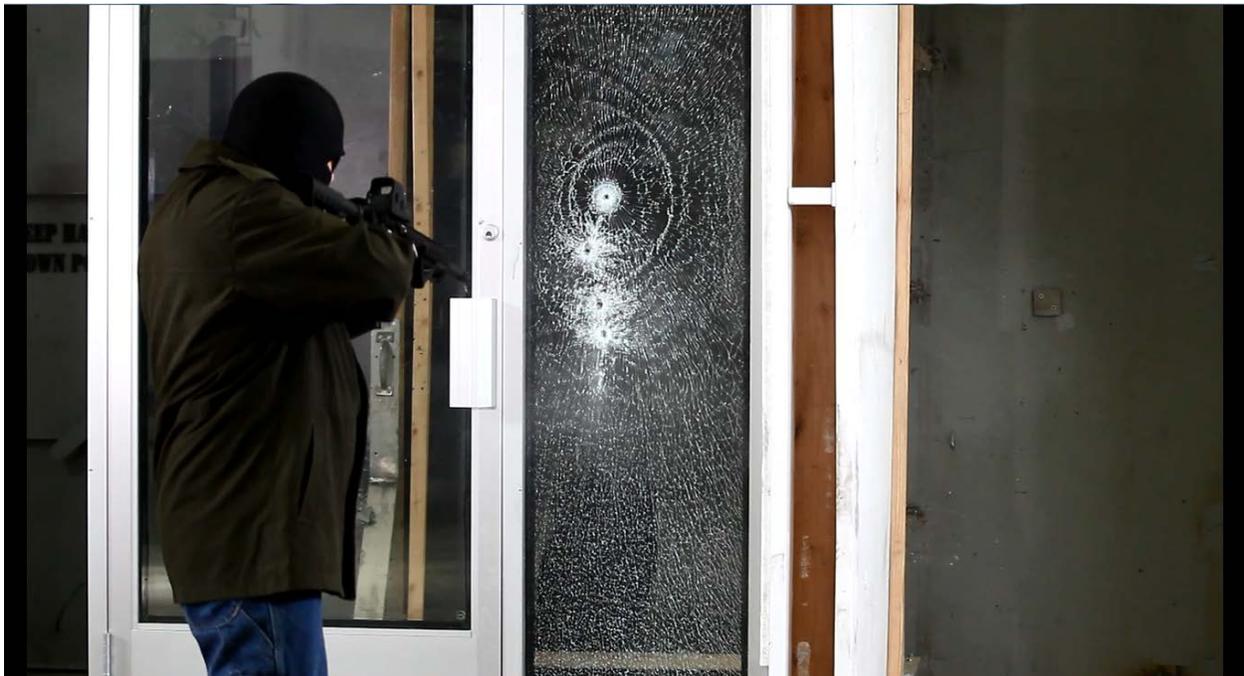
**Photo No. 8**

**Test #4: Competitive 8 mil security film, Semi-automatic rifle attack, after 4 shots.**

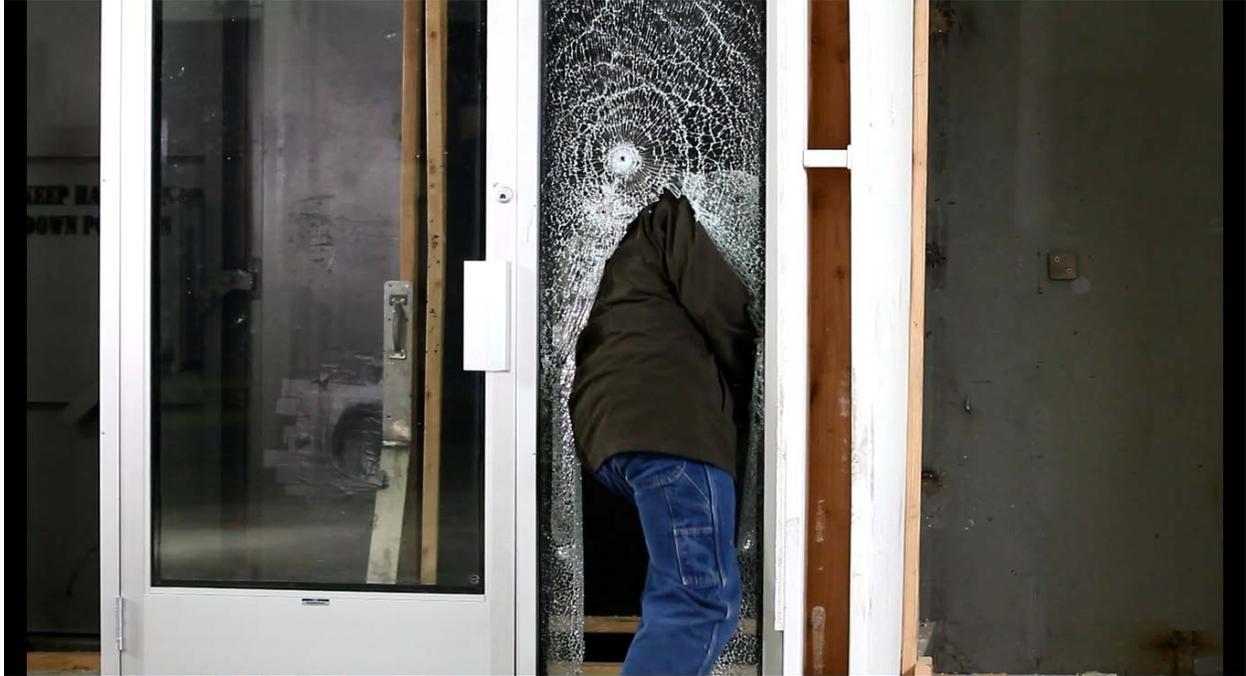
Photo No. 9

Test #4: Semi-automatic rifle attack, accessed gained after 41 impacts and 43 seconds.

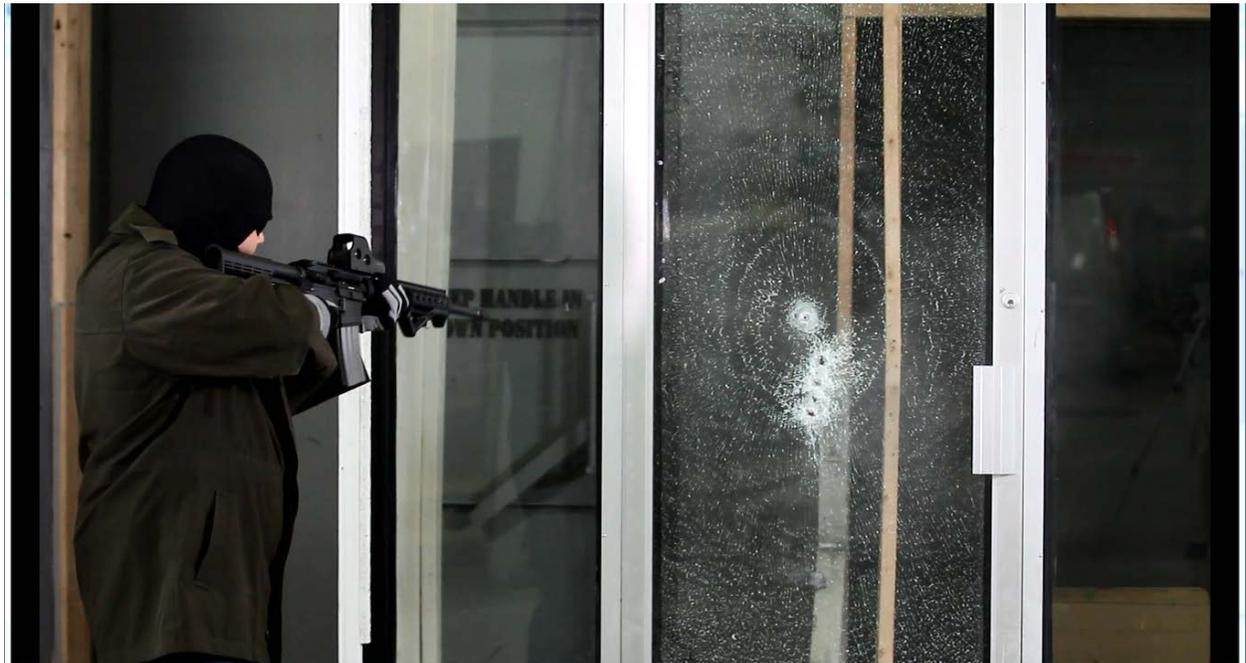
Photo No. 10

Test #5: Semi-automatic rifle attack, 3M Scotchshield Ultra 600 (interior) with Safety S70 Exterior (exterior).

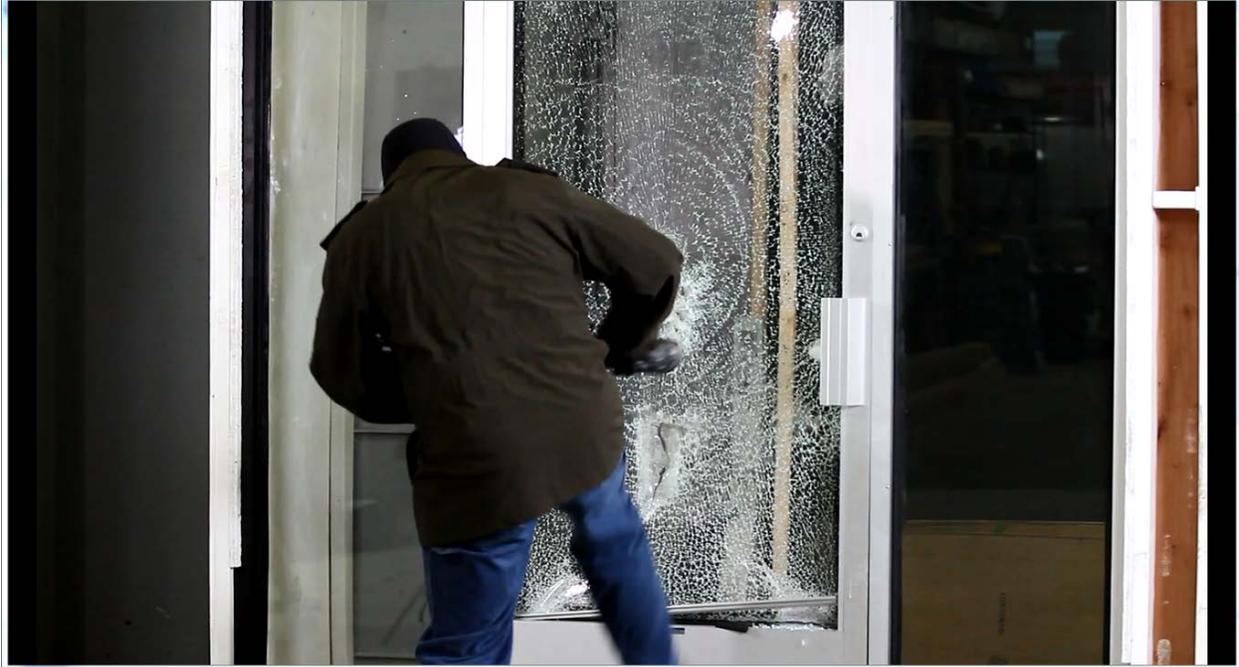
**Photo No. 11**

**Test #5: Semi-automatic rifle attack, after 45 seconds.**

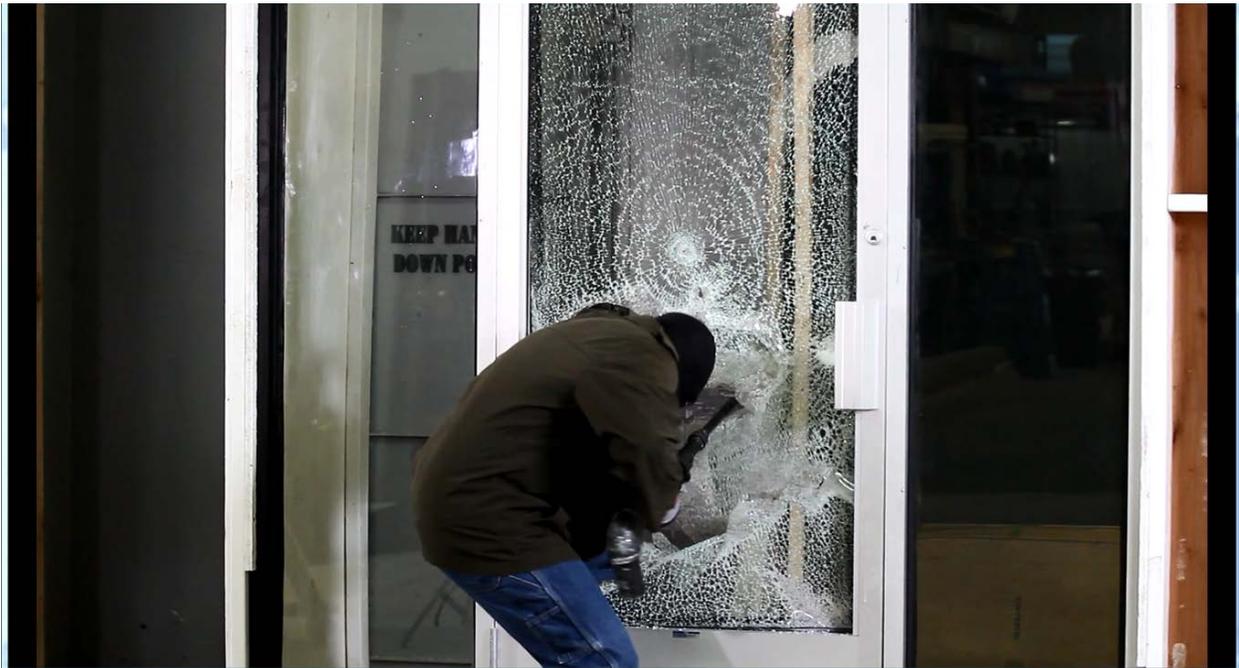
**Photo No. 12**

**Test #5: Semi-automatic rifle attack, access gained 64 impacts and after 81 seconds.**

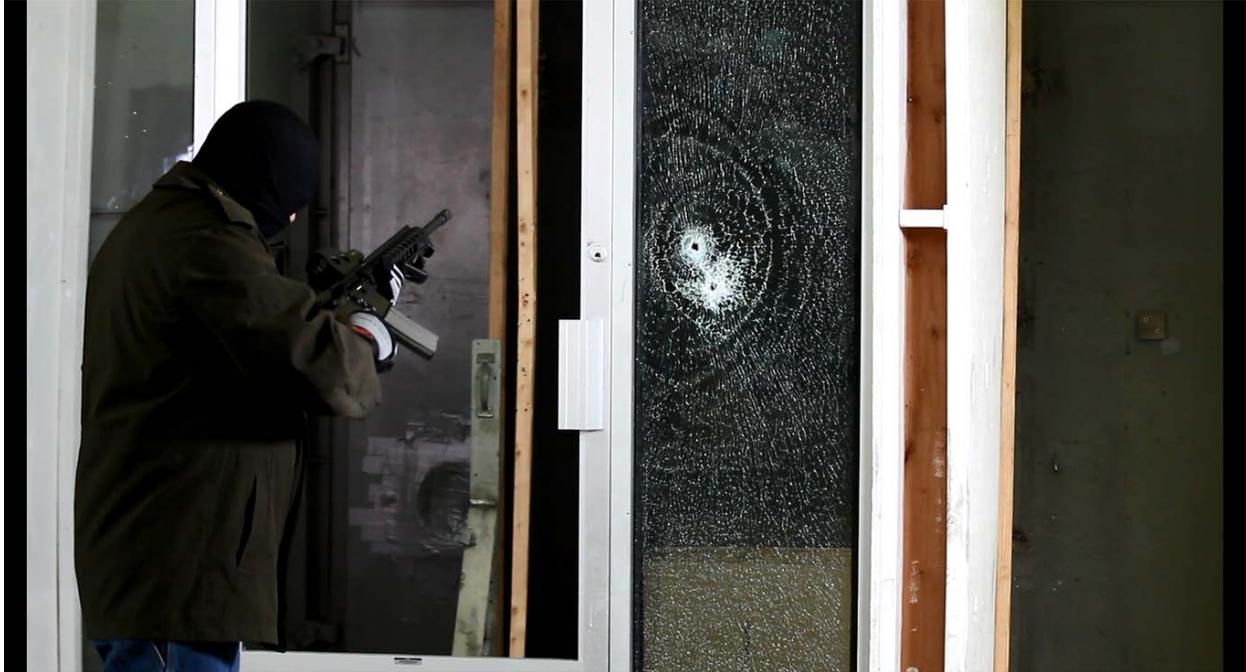
**Photo No. 13**

*Note 2: Includes 3 upper body attacks between shots, and addressing a jammed ammunition cartridge (16 sec).*

**Test #6: 3M Scotchshield Ultra 800, Semi-automatic rifle attack, after 2 shots and jammed gun.**

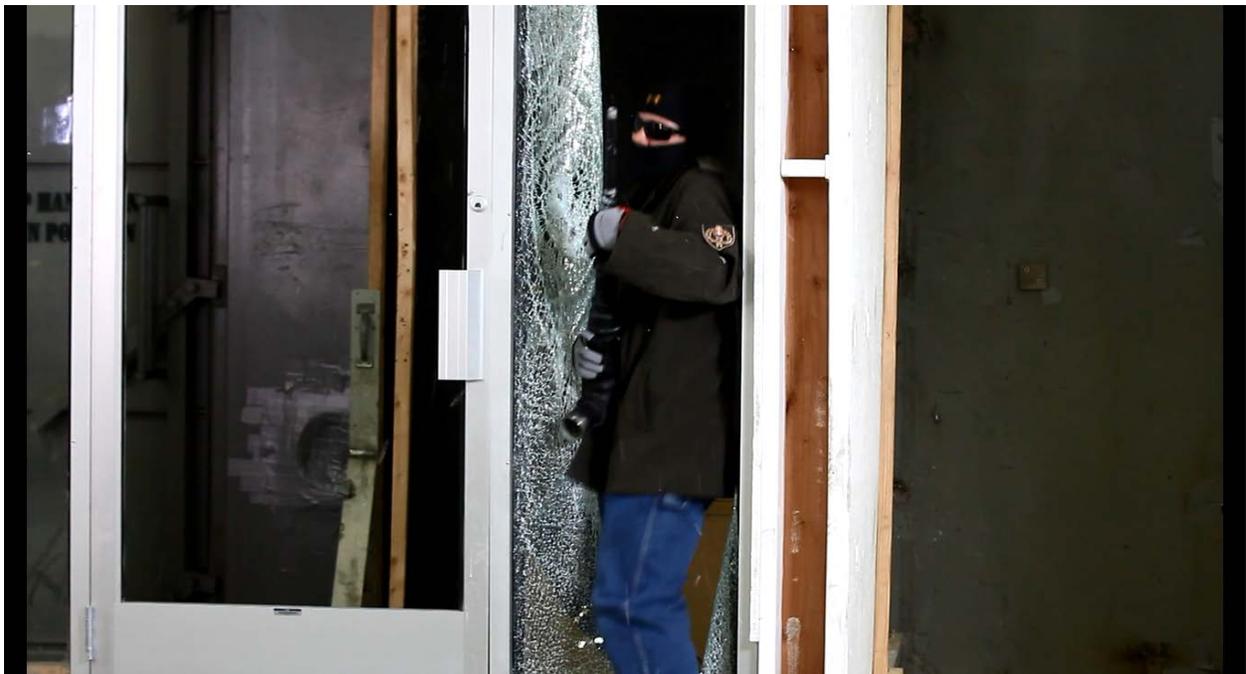
**Photo No. 14**

*Note 4: Attachment system failed (adhesion to frame) before film was able to be penetrated.*

**Test #6: Semi-automatic rifle attack, access gained after 38 impacts and 60 seconds.**

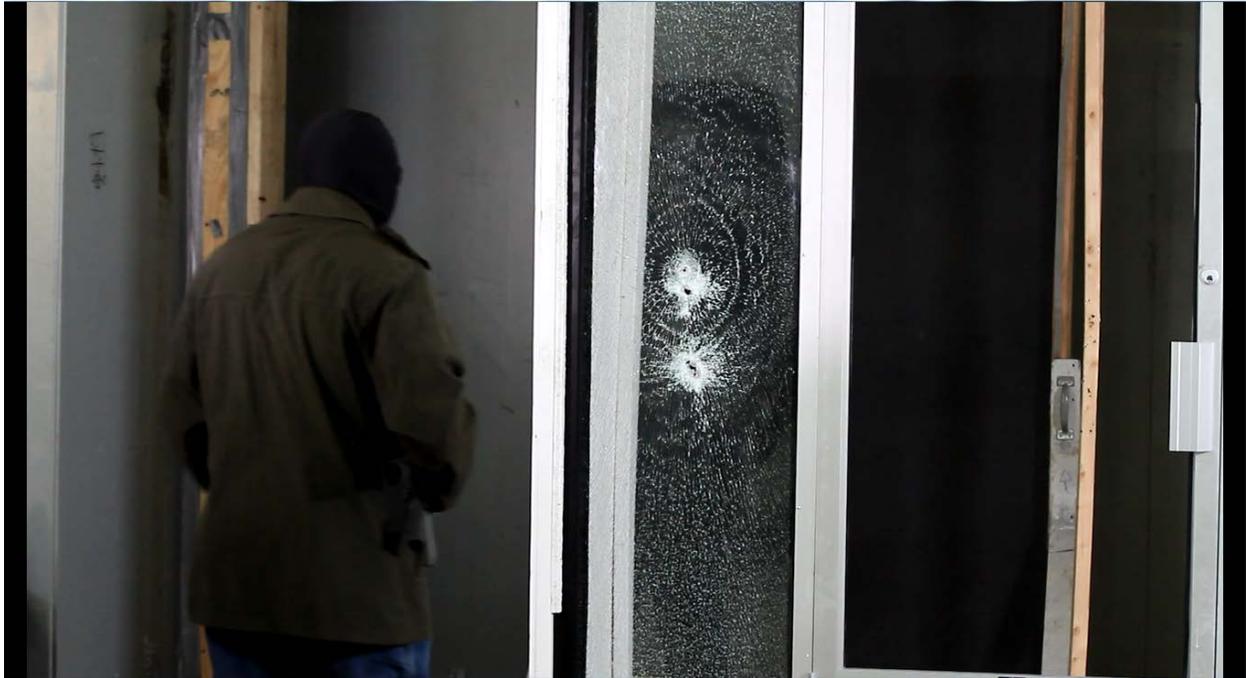
**Photo No. 15**

**Test #7: Semi-automatic rifle attack, 3M Scotchshield Ultra 600 (interior) with Safety S70 Exterior (exterior).**

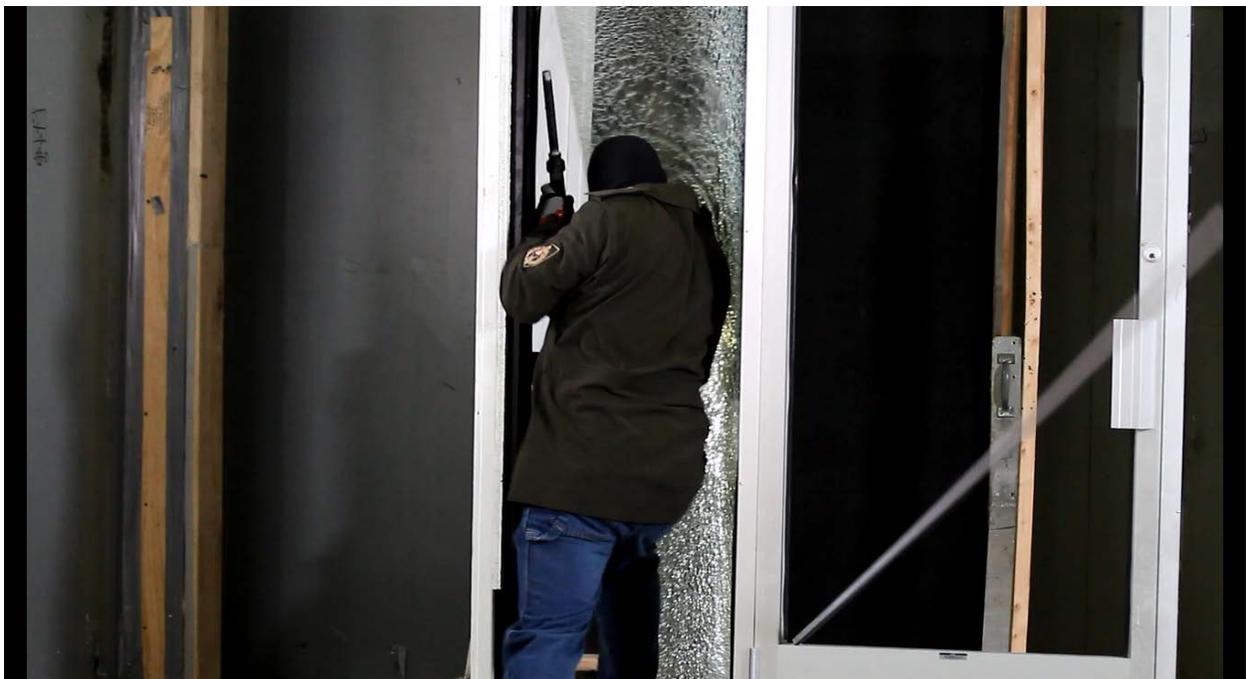
**Photo No. 16**

*Note 4: Attachment system failed (adhesion to film) before film was able to be penetrated.*

**Test #7: Semi-automatic rifle attack, access gained after 30 impacts and 38 seconds.**

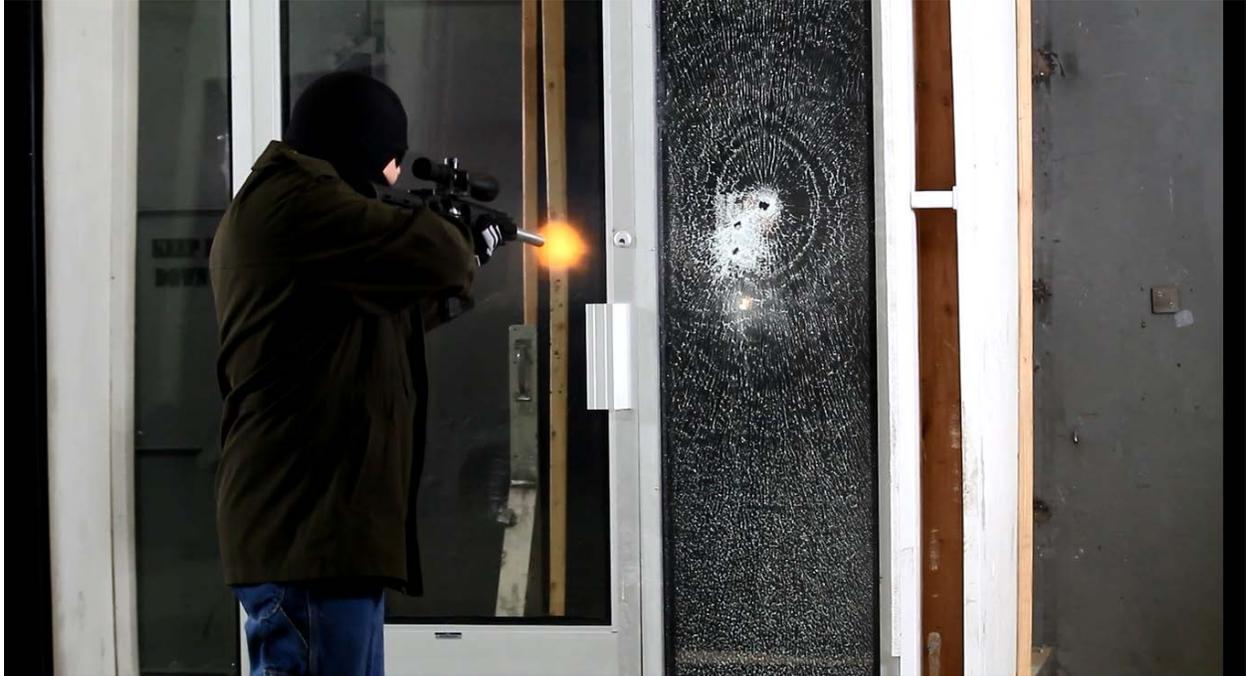
**Photo No. 17**

**Test #8: 3M Scotchshield Ultra 800, Semi-automatic rifle attack, after 4 shots.**

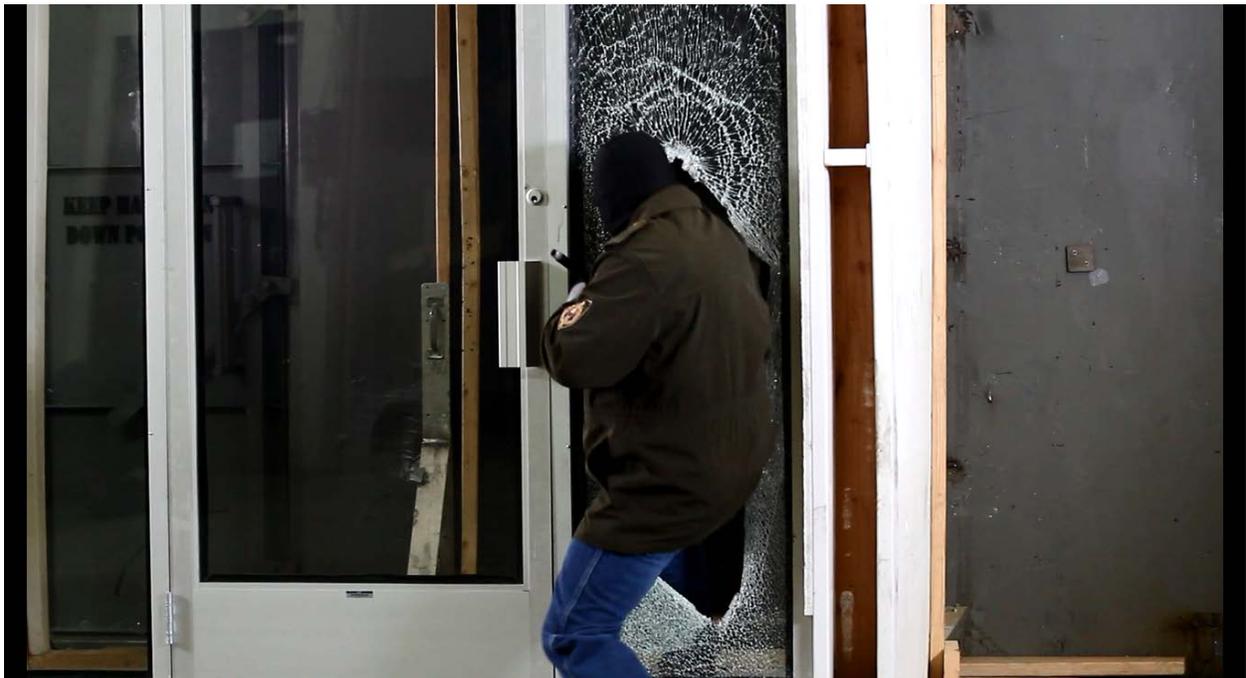
**Photo No. 18**

*Note 4: Film was torn and ripped open to allow complete body passage.*

**Test #8: Semi-automatic rifle attack, access gained after 45 impacts and 50 seconds.**

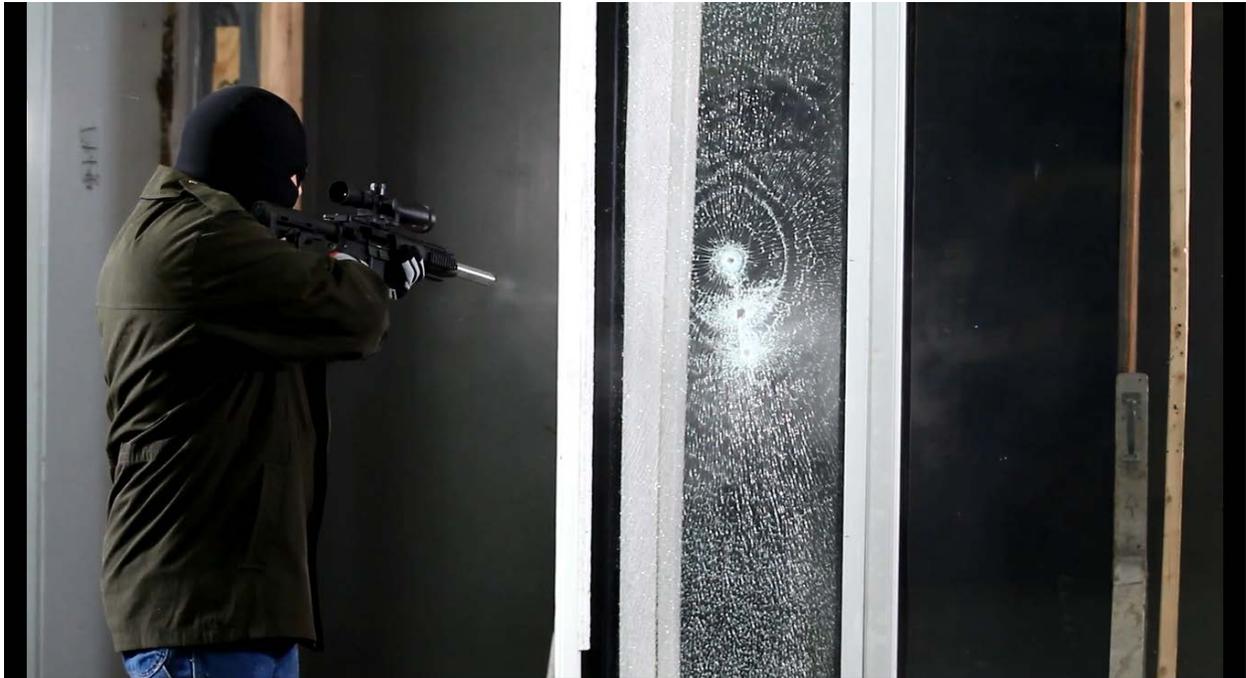
**Photo No. 19**

**Test #9: 3M Scotchshield Ultra 800, Semi-automatic rifle attack, after 4 shots.**

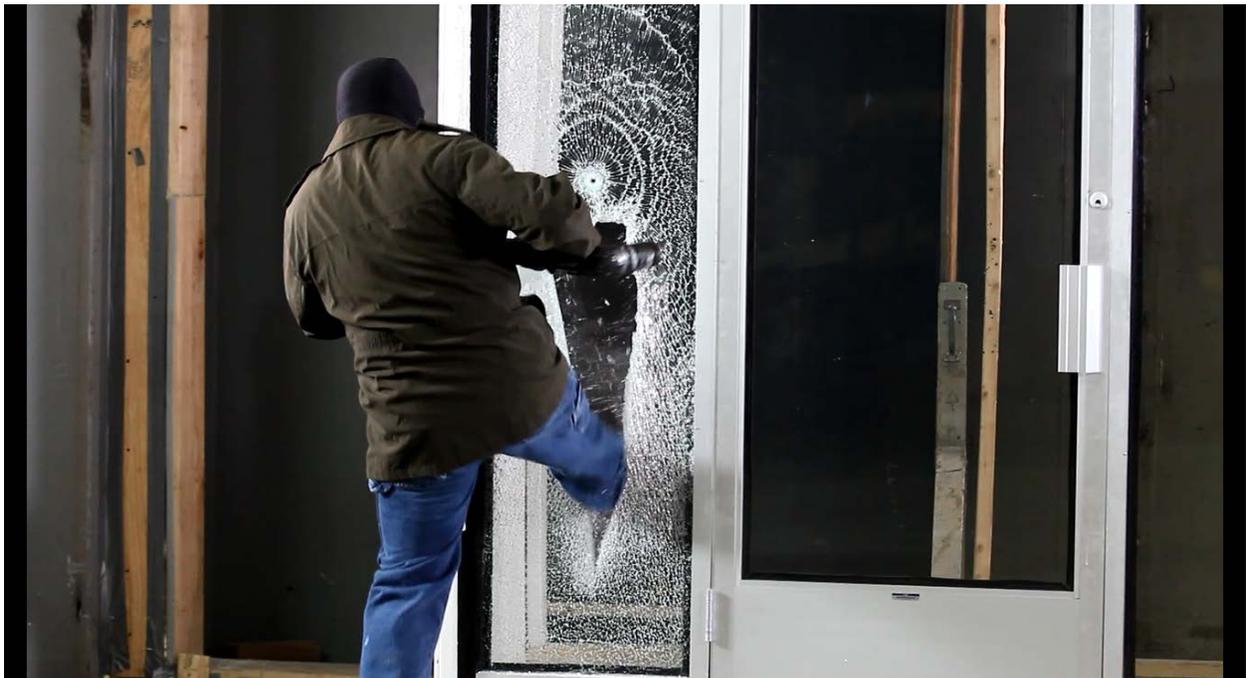
**Photo No. 20**

**Test #9: Semi-automatic rifle attack, after 38 seconds.**

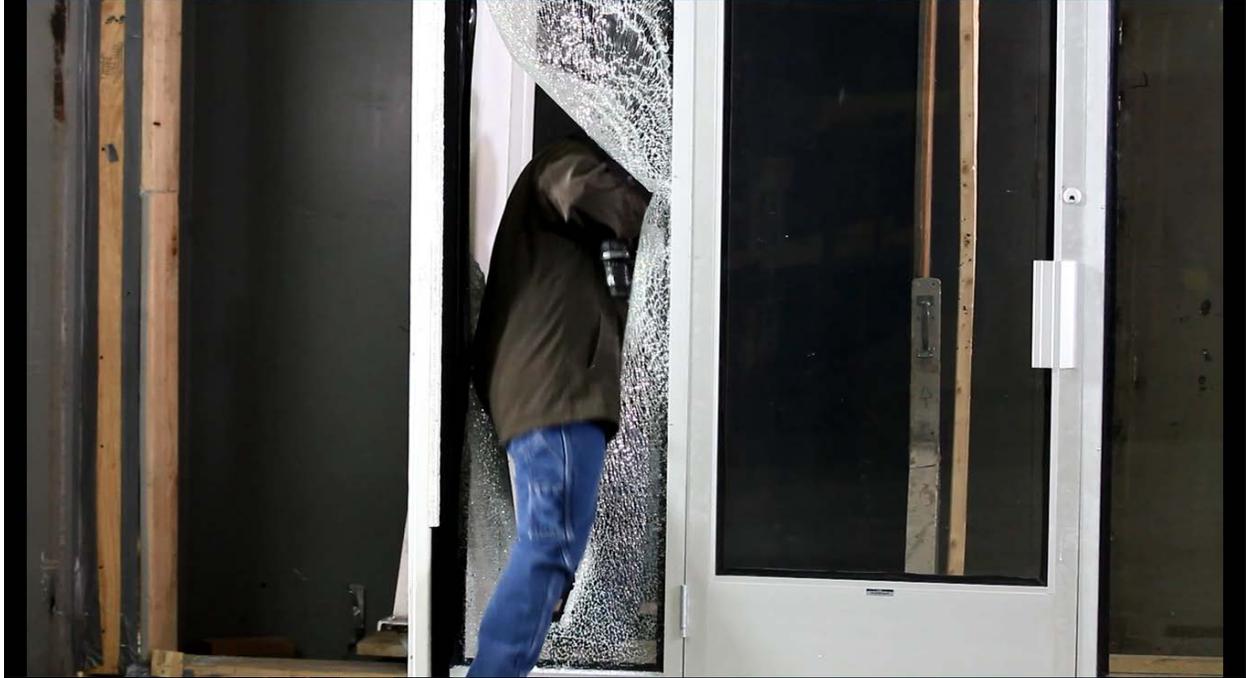
**Photo No. 21**

**Test #9: Semi-automatic rifle attack, access gained after 43 impact and 48 seconds.**

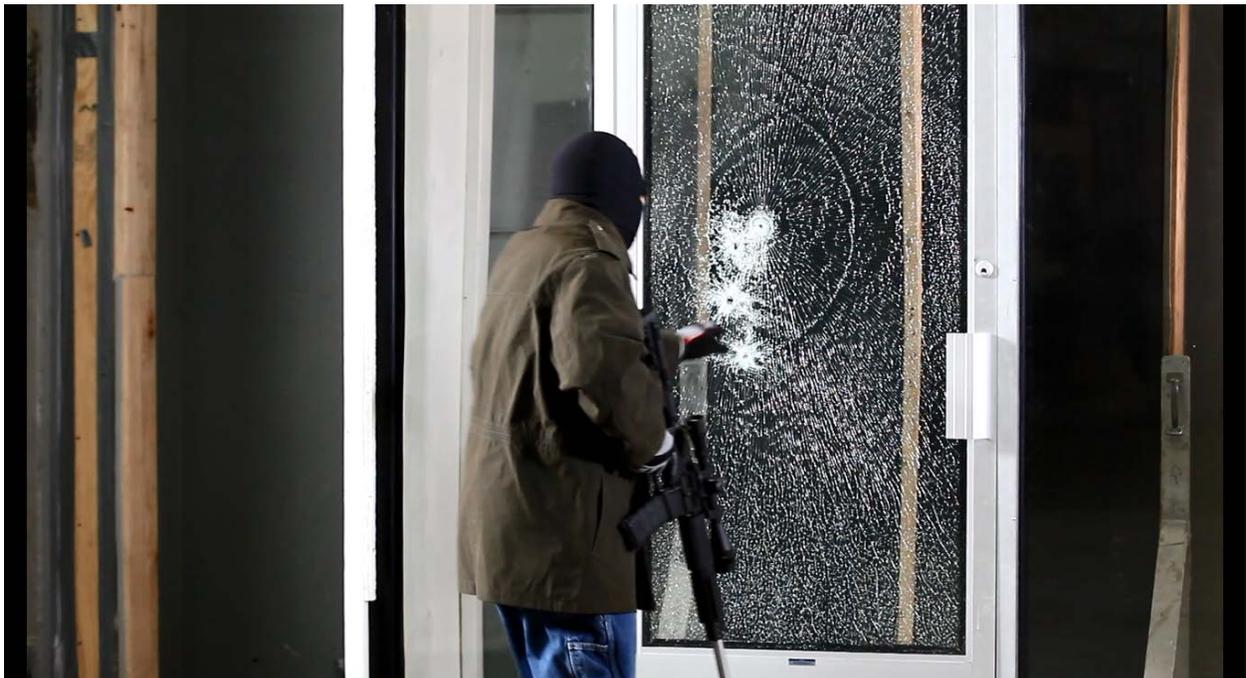
**Photo No. 22**

**Test #10: Semi-automatic rifle attack, 3M Scotchshield Ultra 800 (interior) with Safety S70 Exterior (exterior).**

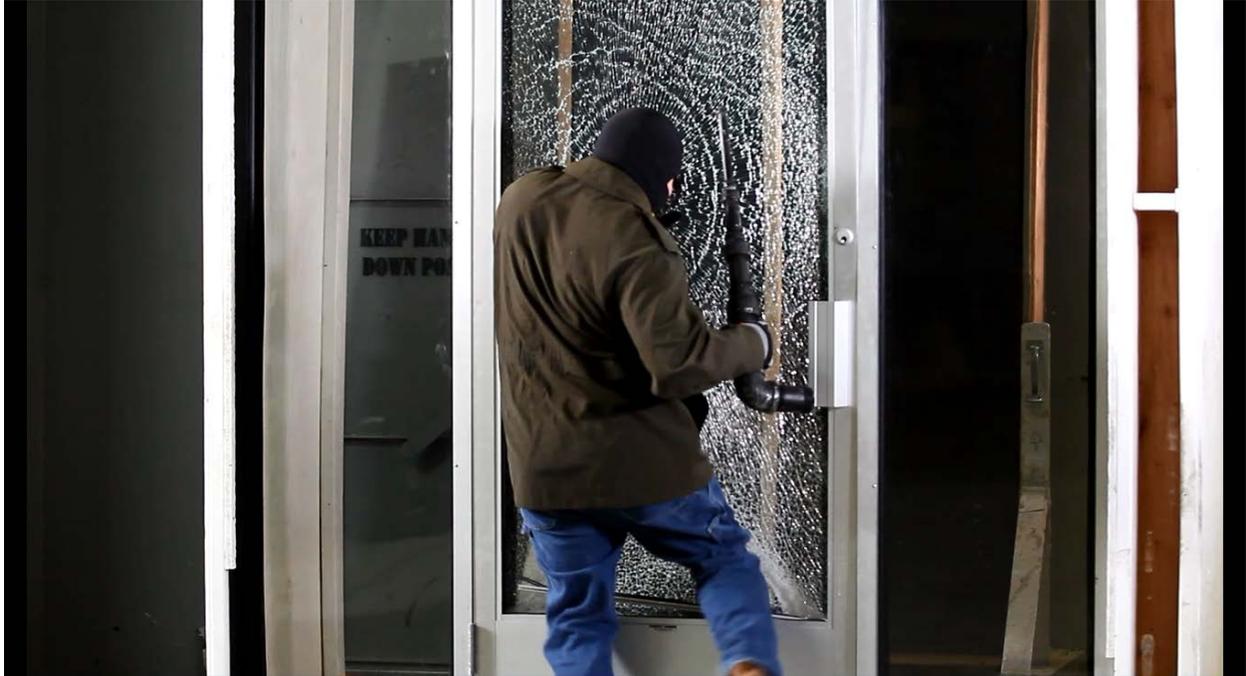
**Photo No. 23**

**Test #10: Semi-automatic rifle attack, after 70 seconds.**

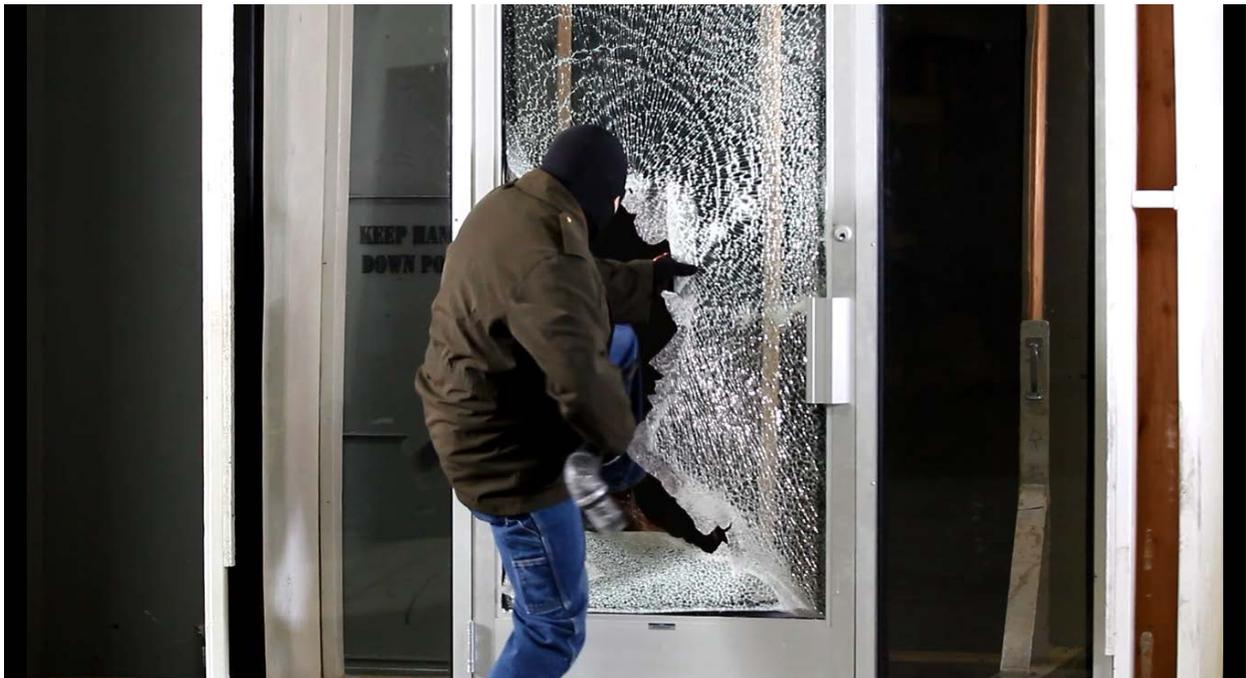
**Photo No. 24**

**Test #10: Semi-automatic rifle attack, access gained after 70 impacts and 91 seconds.**

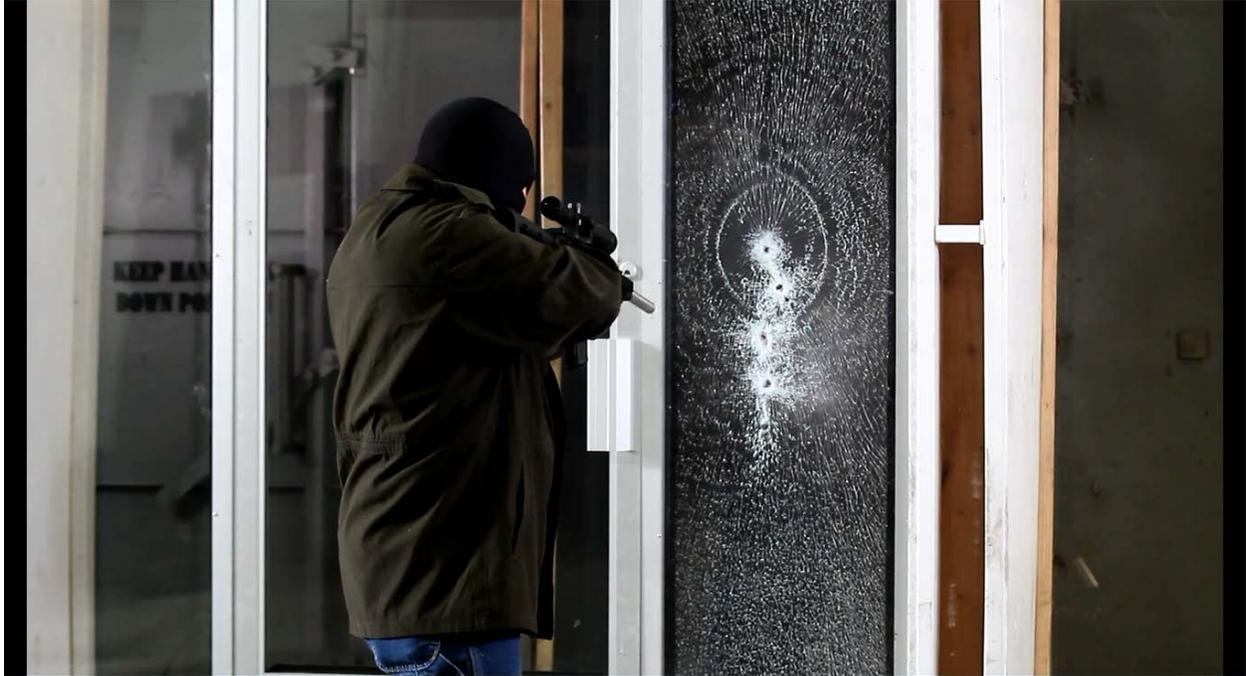
**Photo No. 25**

**Test #11: Competitive 8 mil security film, Semi-automatic rifle attack, after 4 shots.**

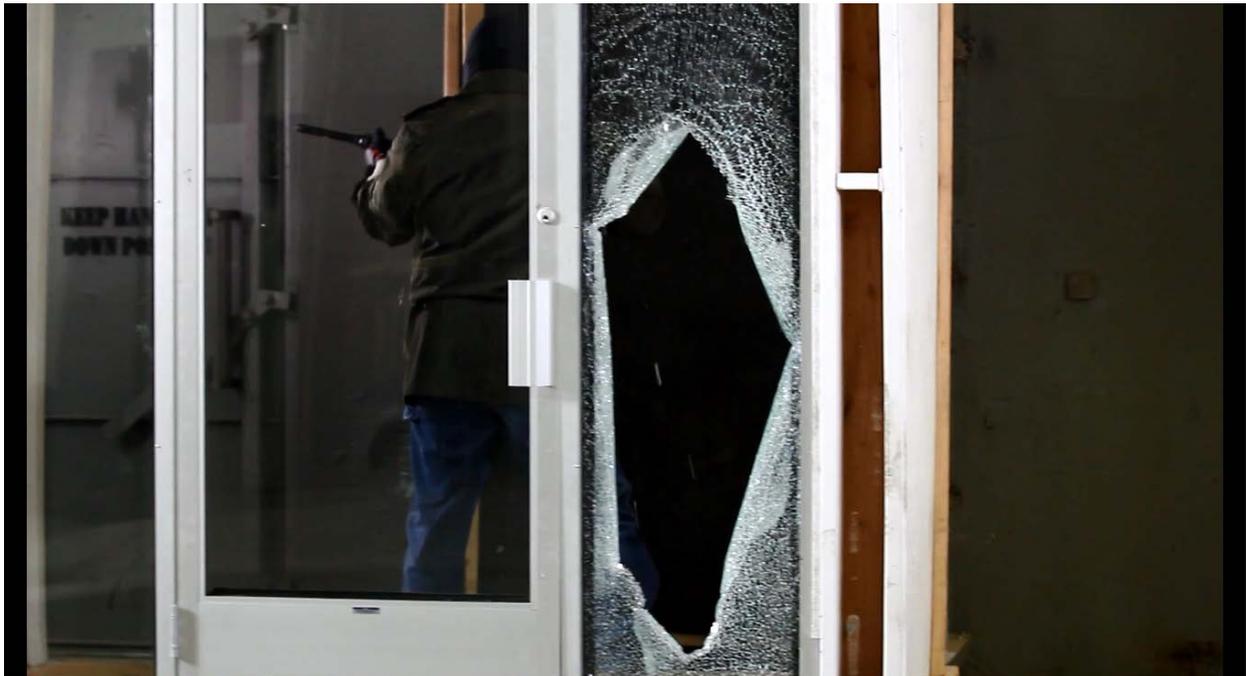
**Photo No. 26**

**Test #11: Semi-automatic rifle attack, access gained after 25 impacts and 29 seconds.**
