**BREAK and ENTRY PERFORMANCE TEST REPORT**

**Report No.:** D5857.01-201-42

3M COMPANY  
St. Paul, Minnesota

**PRODUCT TYPE:** Safety and Security Window Film

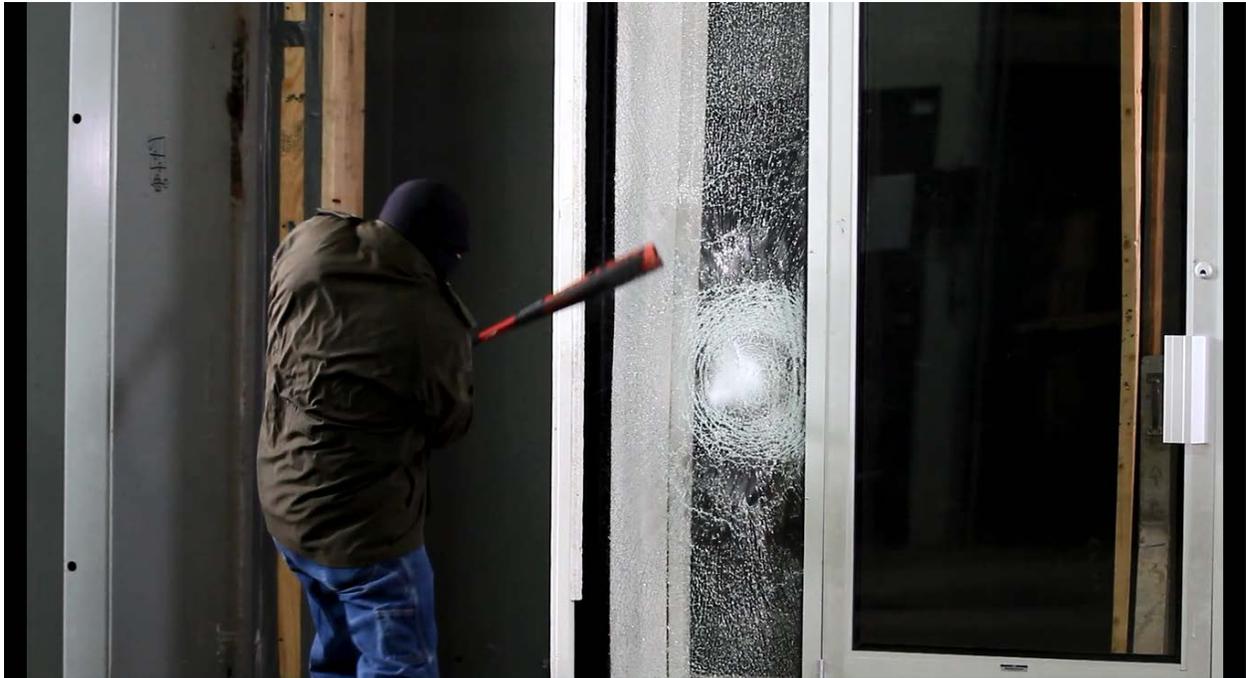
**Photo No. 27**

**Test #12: Bat attack, 3M Scotchshield Ultra 600.**

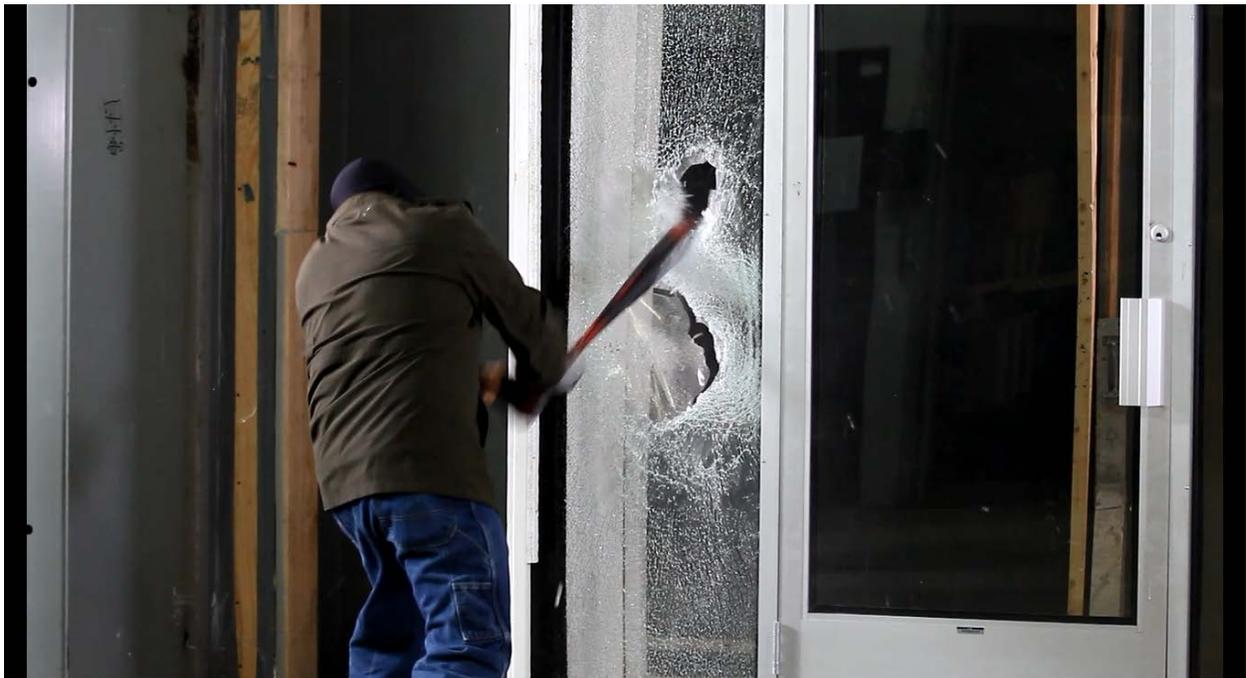
**Photo No. 28**

**Test #12: Bat attack, 3M Scotchshield Ultra 600, after several impacts.**

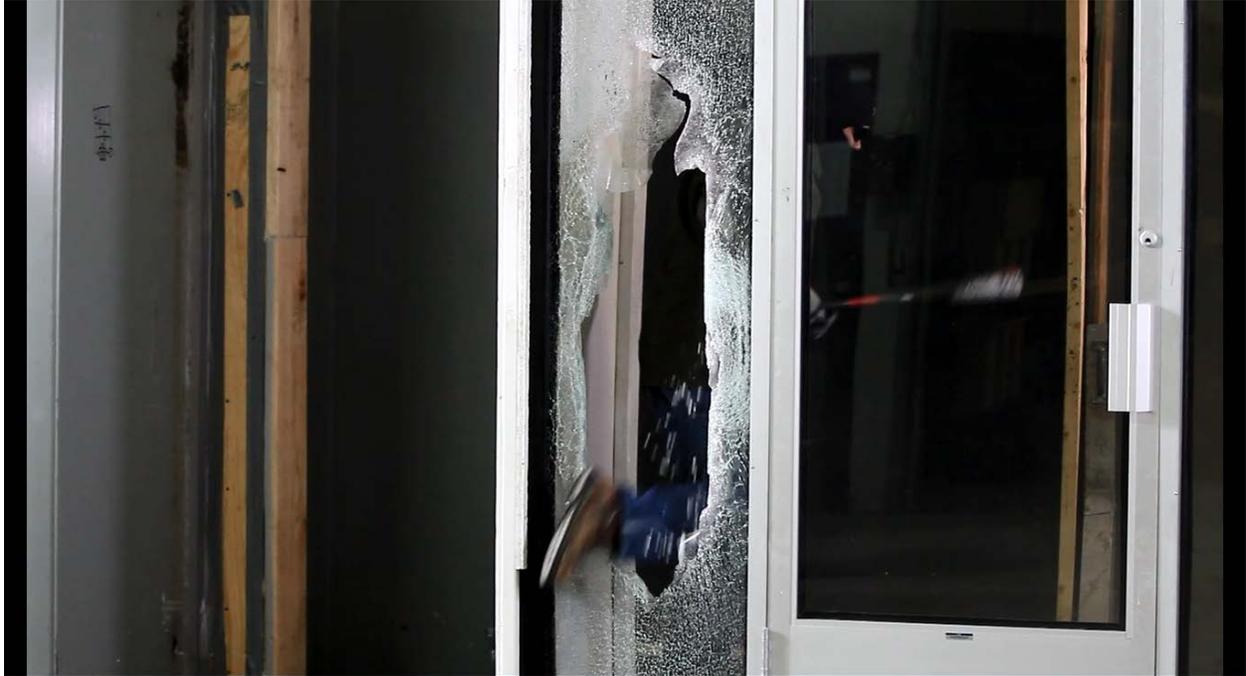
**Photo No. 29**

**Test #12: Bat attack, 3M Scotchshield Ultra 600, access gained after 15 impacts and 12 seconds.**

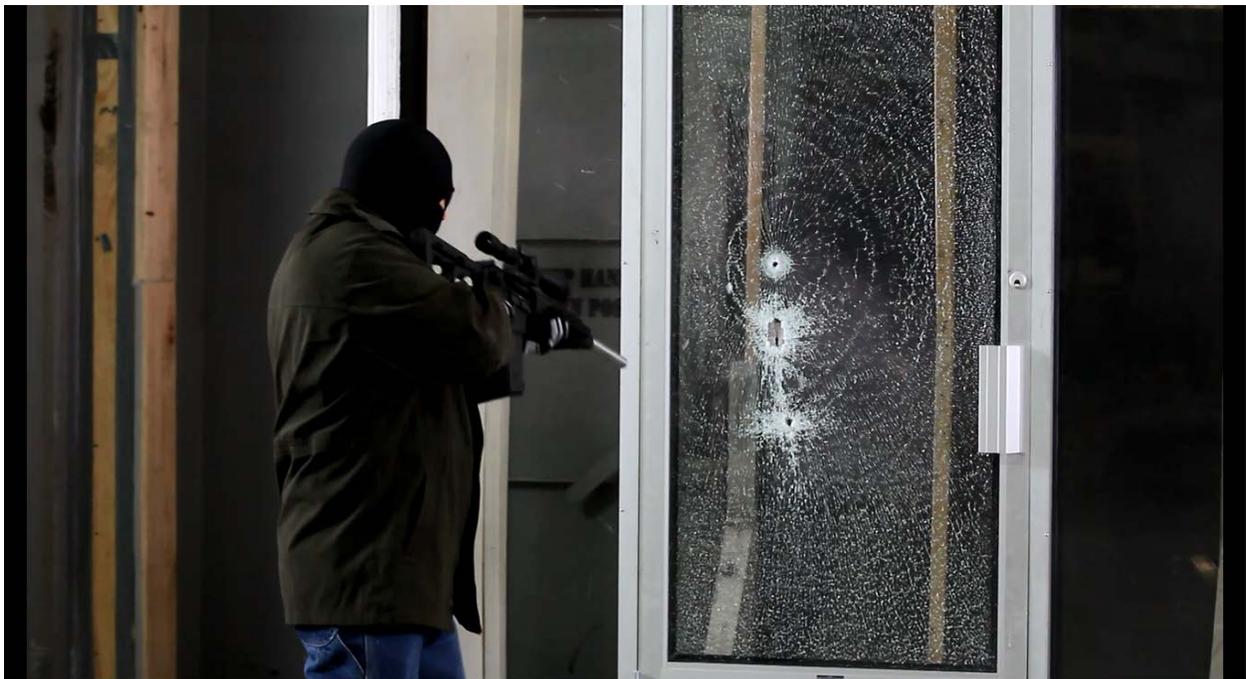
**Photo No. 30**

**Test #13: 3M Scotchshield Ultra 600, Semi-automatic rifle attack, after 4 shots.**

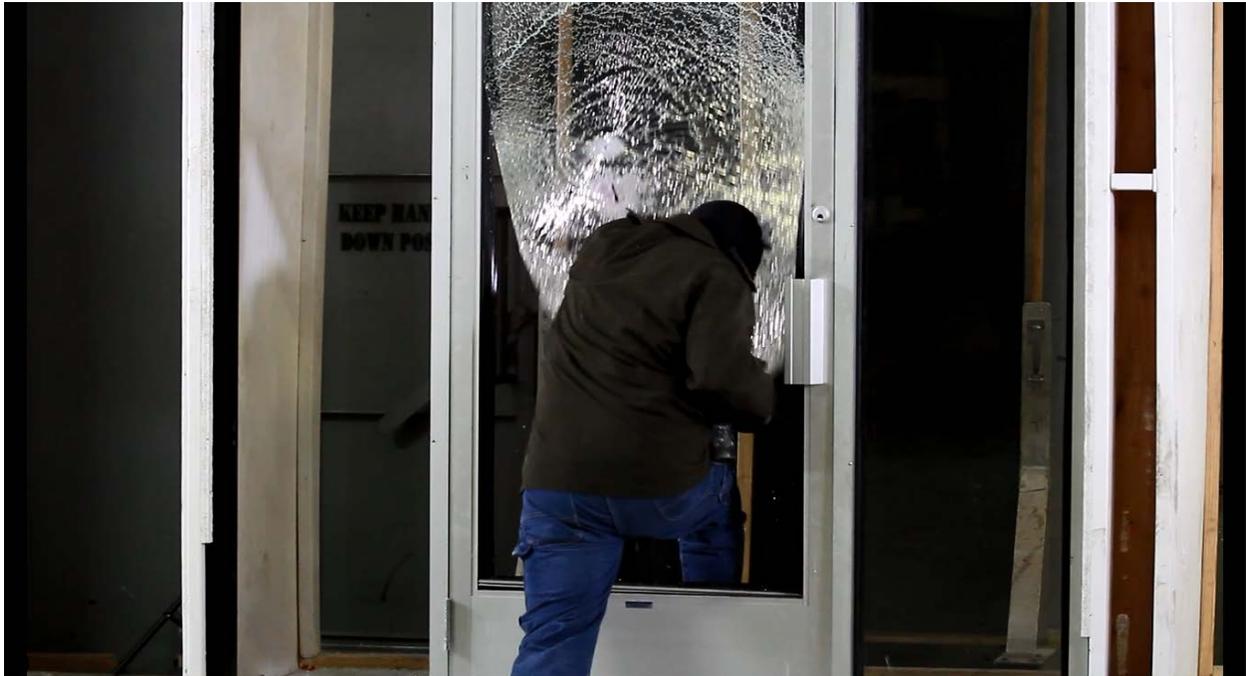
**Photo No. 31**

*Note 4: Attachment system failure (adhesion to film). Not enough time allowed for attachment to cure prior to testing.*

**Test #13: Semi-automatic rifle attack, access gained after 19 impacts and 18 seconds (film attachment failed – adhesion to film).**

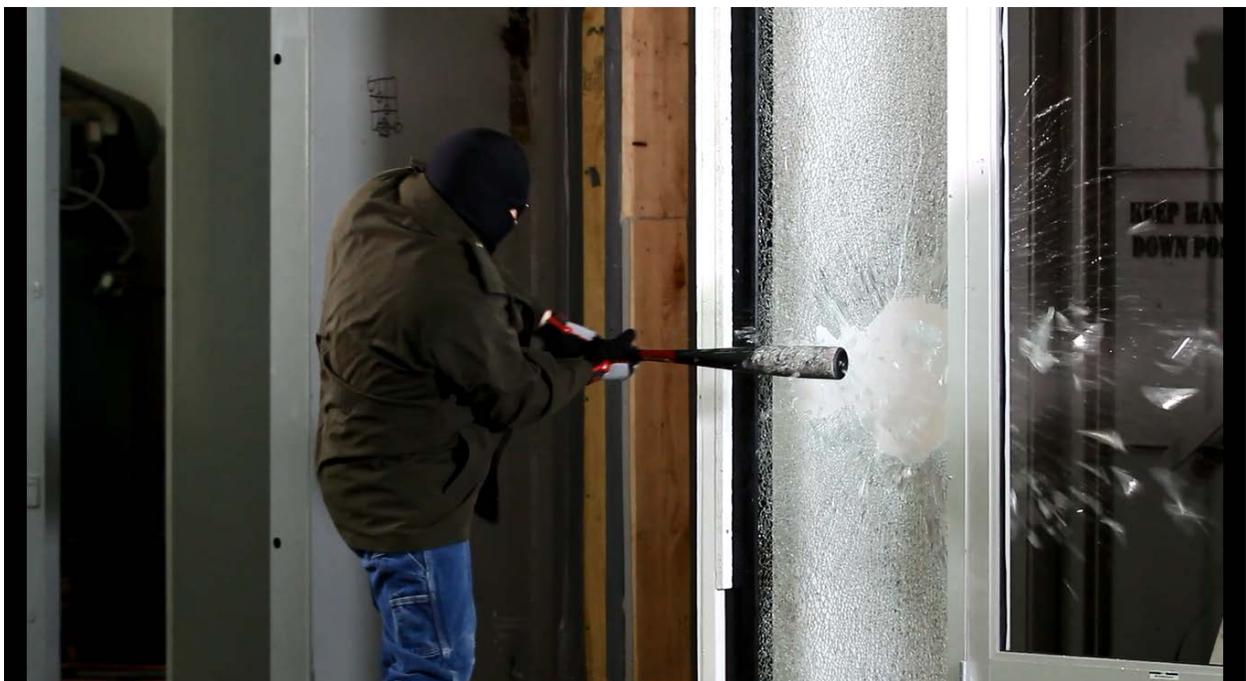
**Photo No. 32**

**Test #14: Bat attack, NO FILM.**

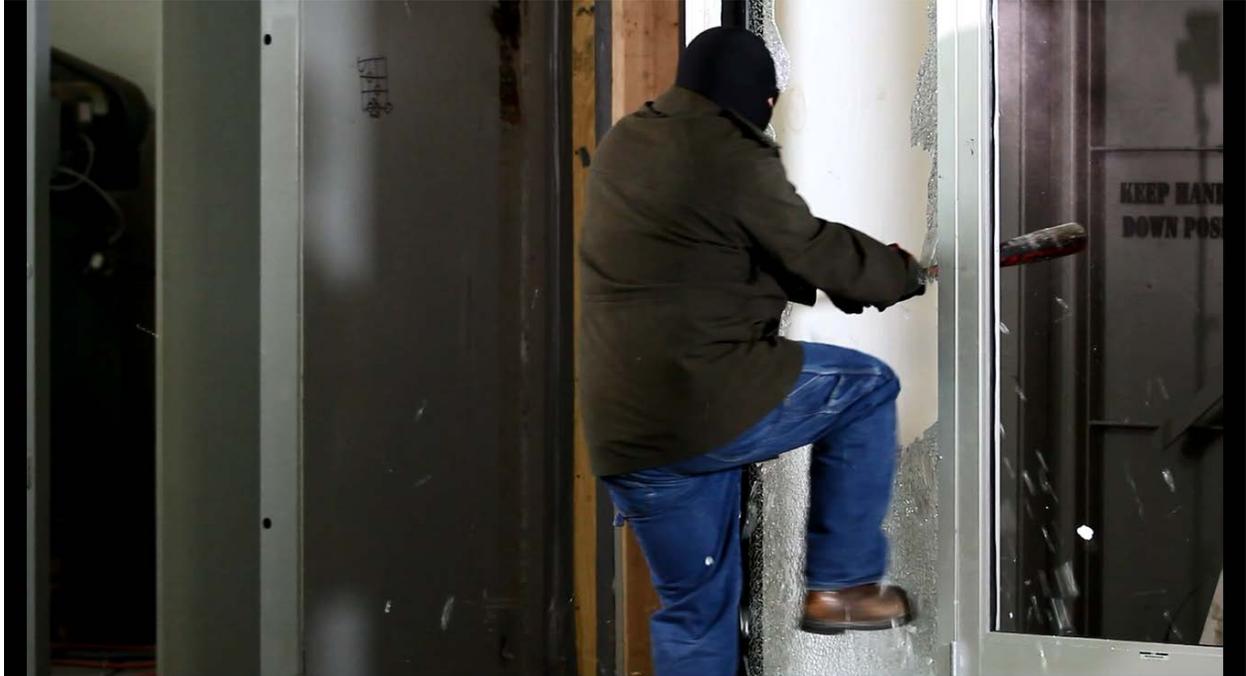
**Photo No. 33**

*Note 1: First 2 strikes with bat did not break glass*

**Test #14: Bat attack, NO FILM, access gained in 6 seconds.**

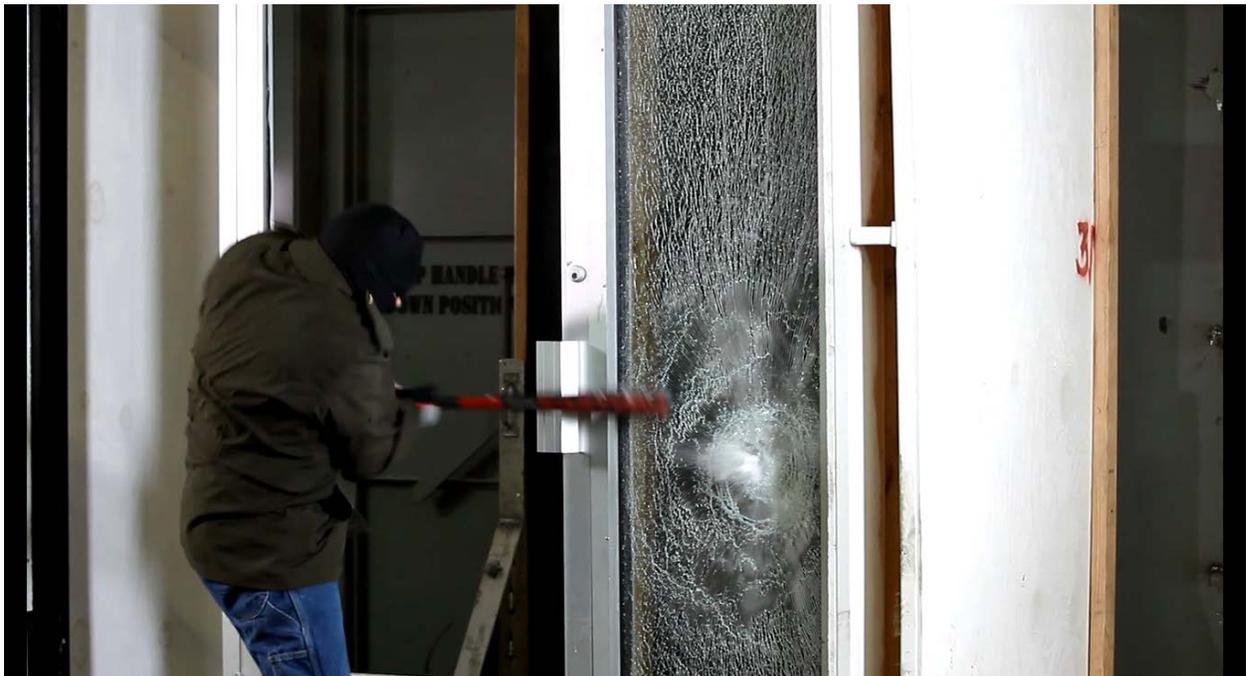
**Photo No. 34**

**Test #15: Bat attack, 3M Safety S80.**

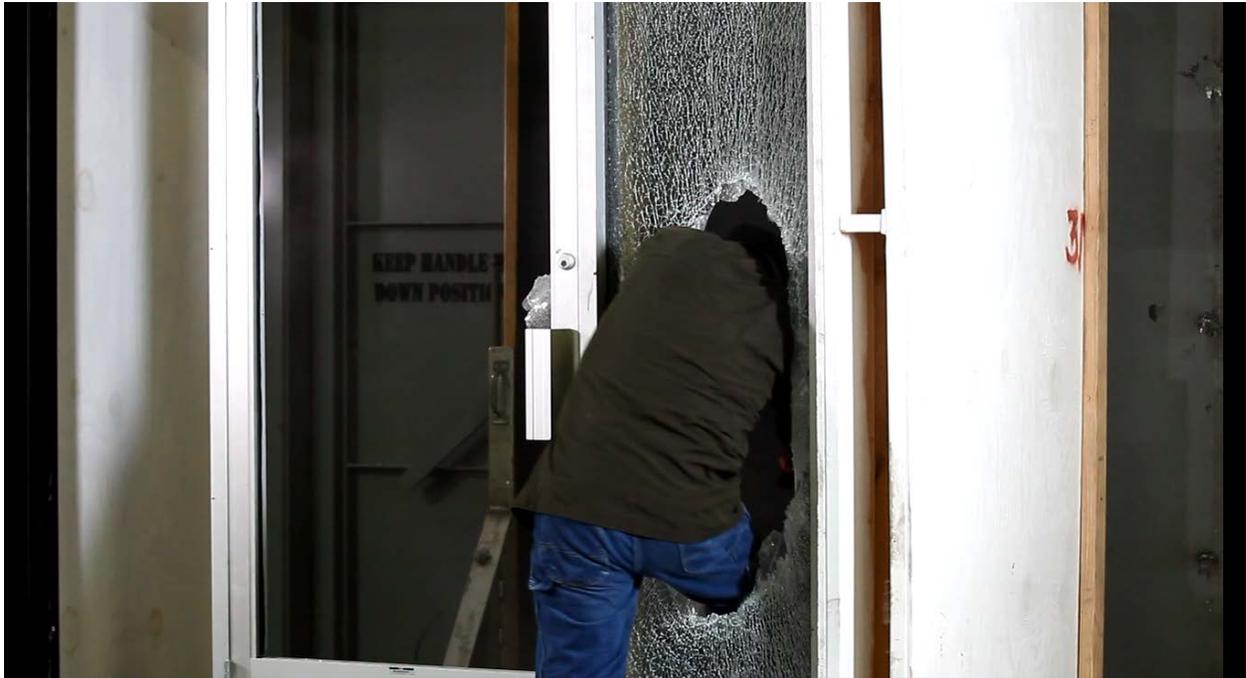
**Photo No. 35**

*Note 1: First 5 strikes with bat did not break glass*

**Test #15: Bat attack, 3M Safety S80, access gained after 17 impacts and 16 seconds.**
