BREAK and ENTRY PERFORMANCE TEST REPORT

Report No.: D5857.03-201-42

3M COMPANY
St. Paul, Minnesota

PRODUCT TYPE: Safety and Security Window Film

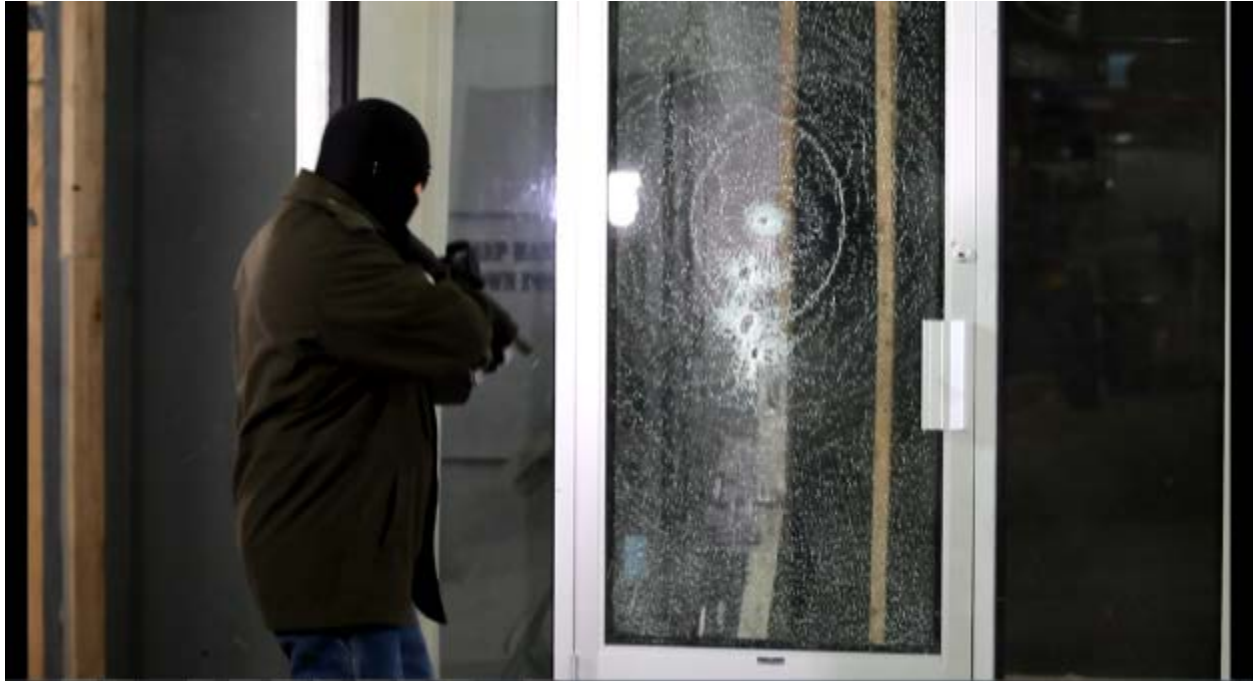
Photo No. 1

Test #1: 3M Ultra 800, Semi-automatic rifle attack, after 4 shots.

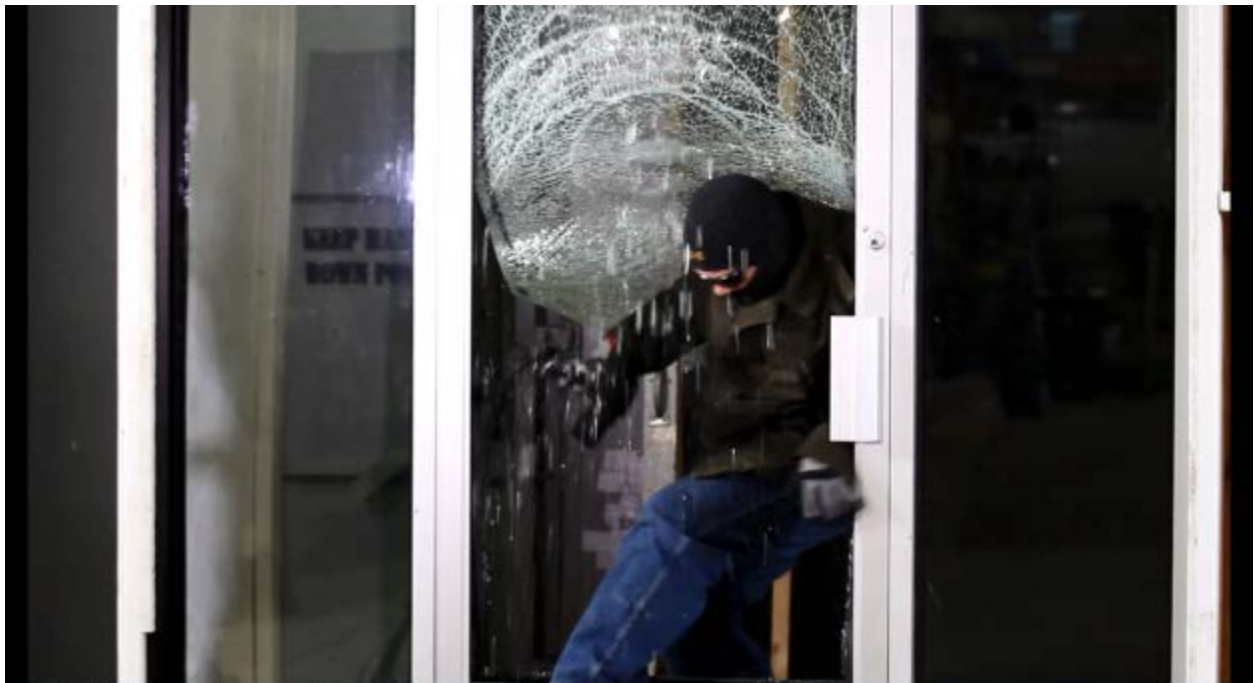
Photo No. 2

5.6 Result: A total of 35 seconds elapsed before the attacker was able to gain access through door entryway system

Note 4: Attachment system failed before film penetration. Not enough time allowed for attachment system adhesive bond to cure.

Test #1: Semi-automatic rifle attack, accessed gained after 33 impacts and 35 seconds.

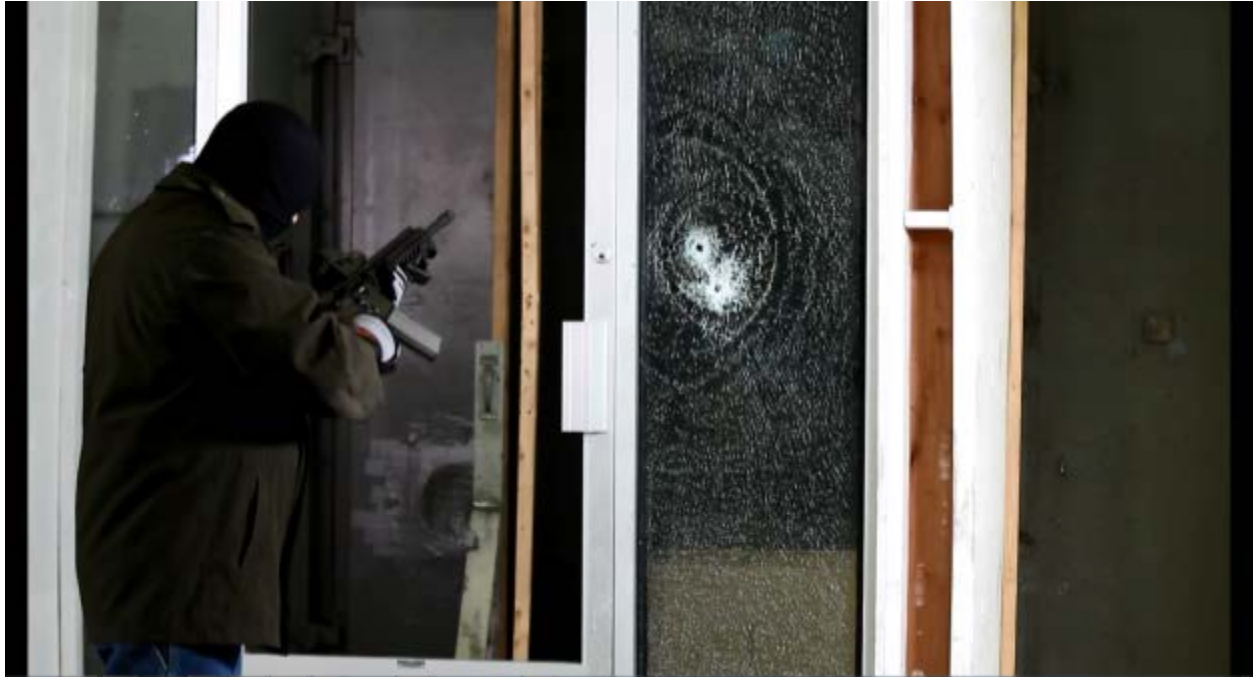
Photo No. 3

Note 2: Includes 3 upper body attacks between shots, and addressing a jammed ammunition cartridge (16 sec).

Test #2: 3M Ultra 800, Semi-automatic rifle attack, after 2 shots and jammed gun.

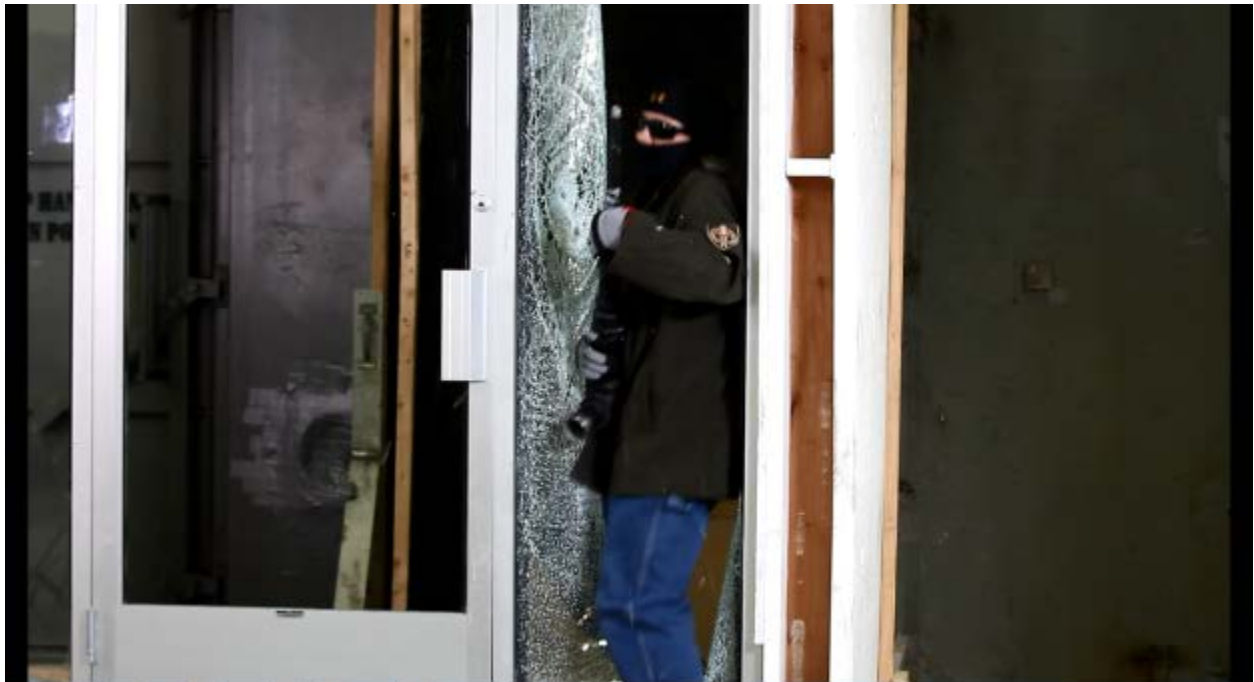
Photo No. 4

6.6 Result: A total of 60 seconds elapsed before the attacker was able to gain access through door entryway system.

Note 4: Attachment system failed (adhesion to frame) before film was able to be penetrated.

Test #2: Semi-automatic rifle attack, access gained after 38 impacts and 60 seconds.

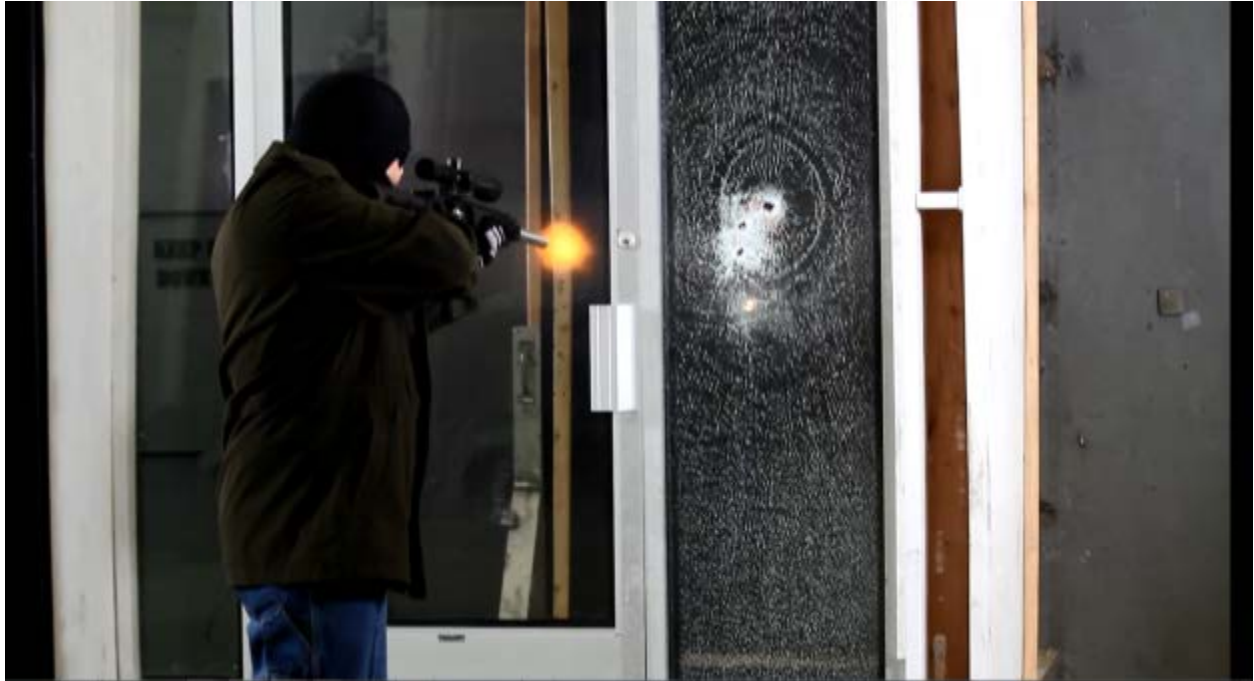
Photo No. 5

Test #3: 3M Ultra 800, Semi-automatic rifle attack, after 4 shots.

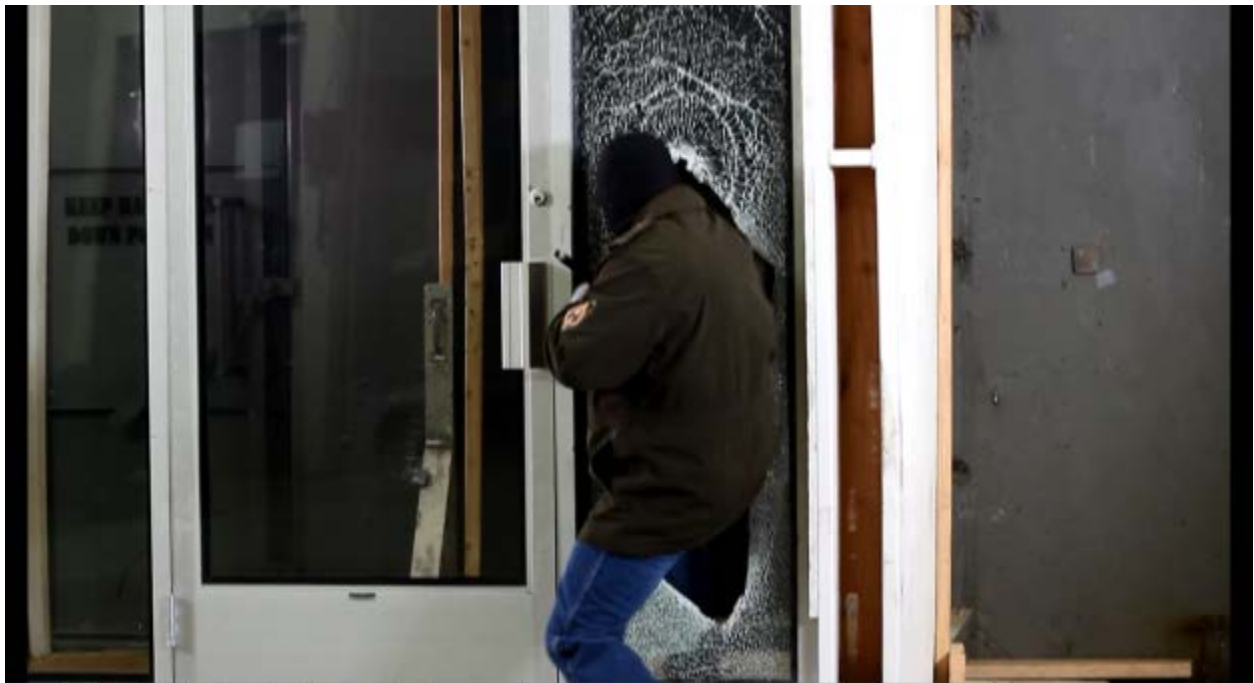
Photo No. 6

7.6 Result: A total of 50 seconds elapsed before the attacker was able to gain access through door entryway system

Note 4: Film was torn and ripped open to allow complete body passage.

Test #3: Semi-automatic rifle attack, access gained after 45 impacts and 50 seconds.

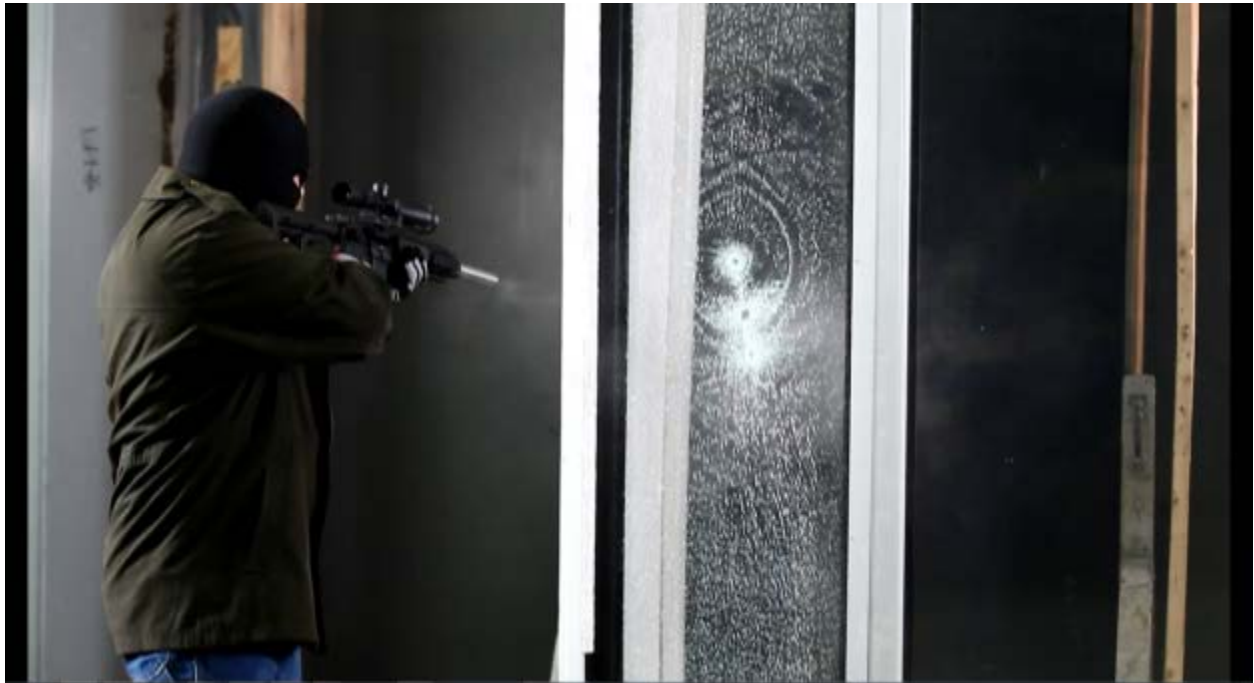
Photo No. 7

Test #4: 3M Ultra 800, Semi-automatic rifle attack, after 4 shots.

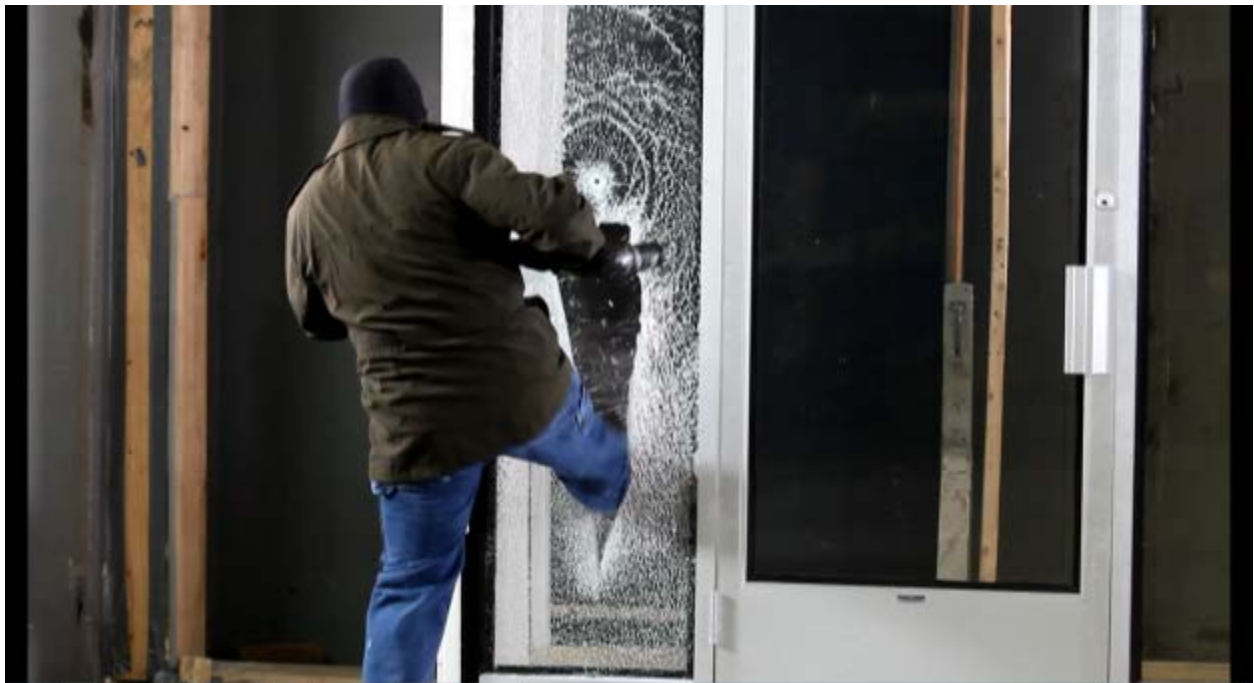
Photo No. 8

Test #4: Semi-automatic rifle attack, after 38 seconds.

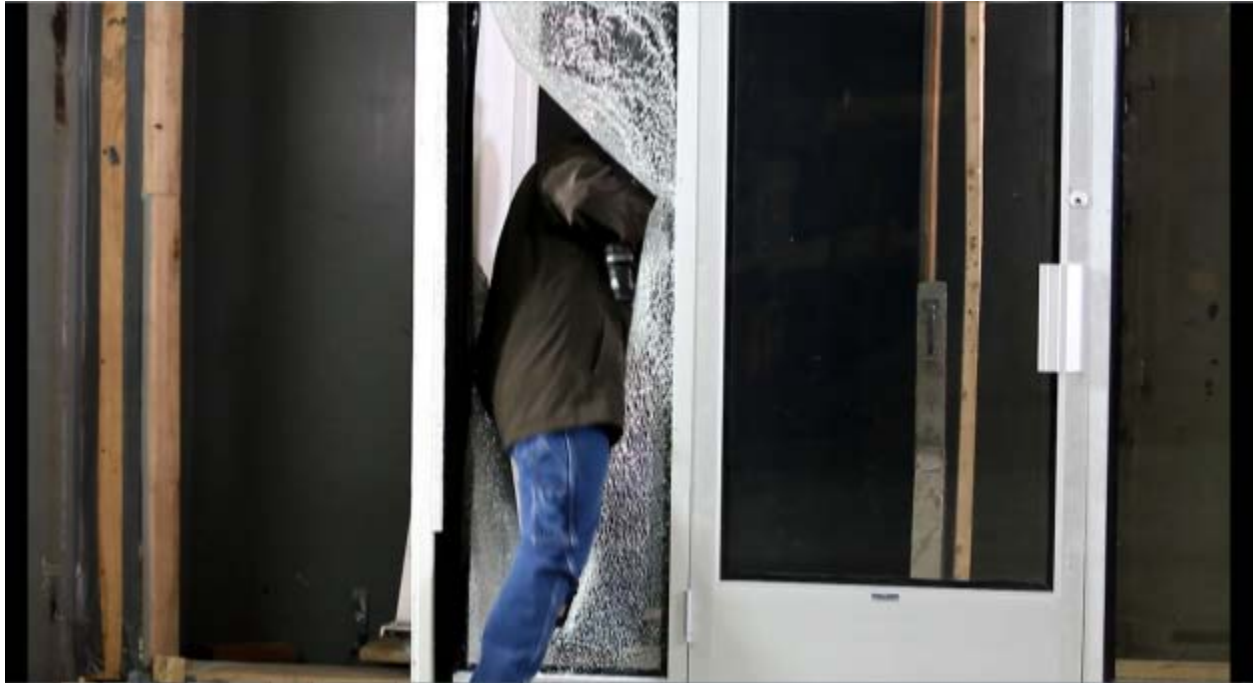
Photo No. 9

8.6 Result: A total of 48 seconds elapsed before the attacker was able to gain access through door entryway system

Test #4: Semi-automatic rifle attack, access gained after 43 impact and 48 seconds.

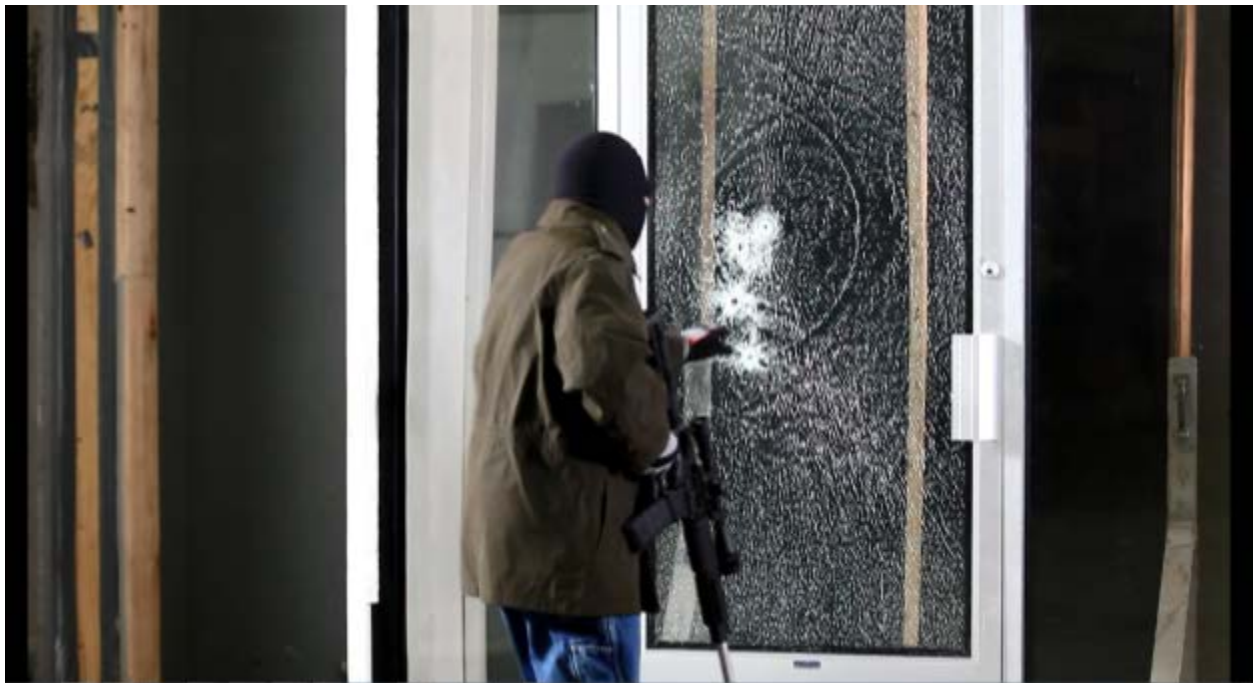
Photo No. 10

Test #5: Semi-automatic rifle attack, 3M Ultra 800 (interior) with Safety S70 Exterior (exterior).

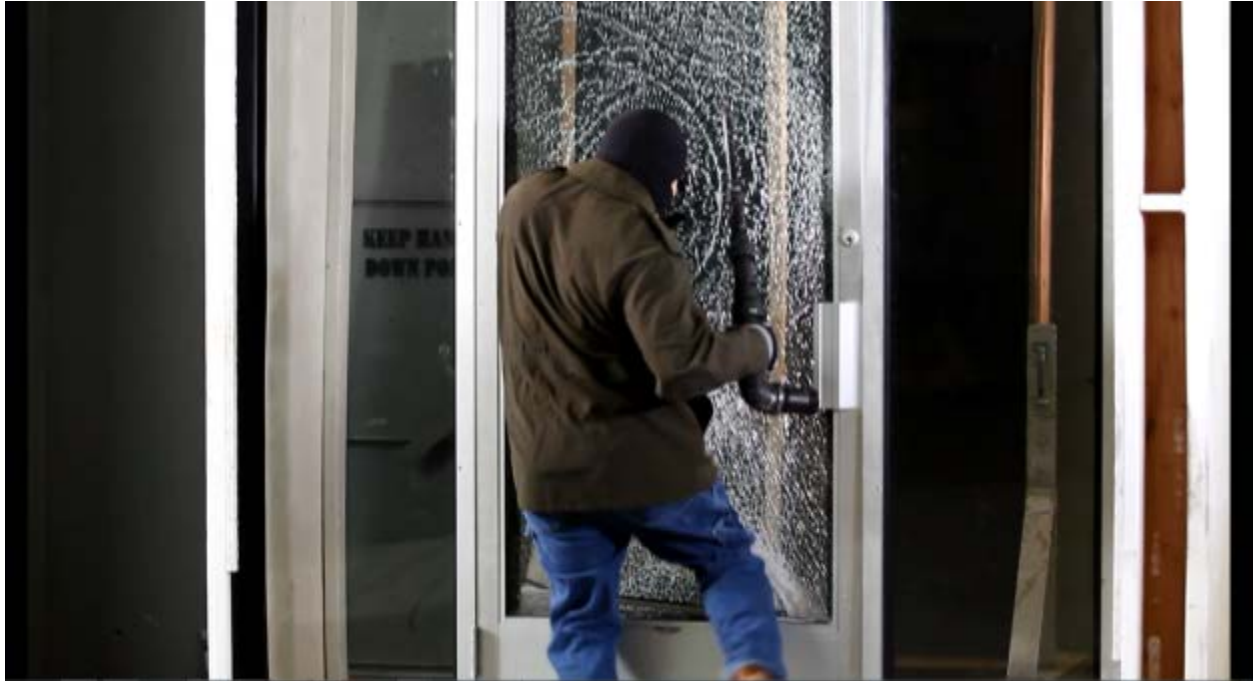
Photo No. 11

Test #5: Semi-automatic rifle attack, after 70 seconds.

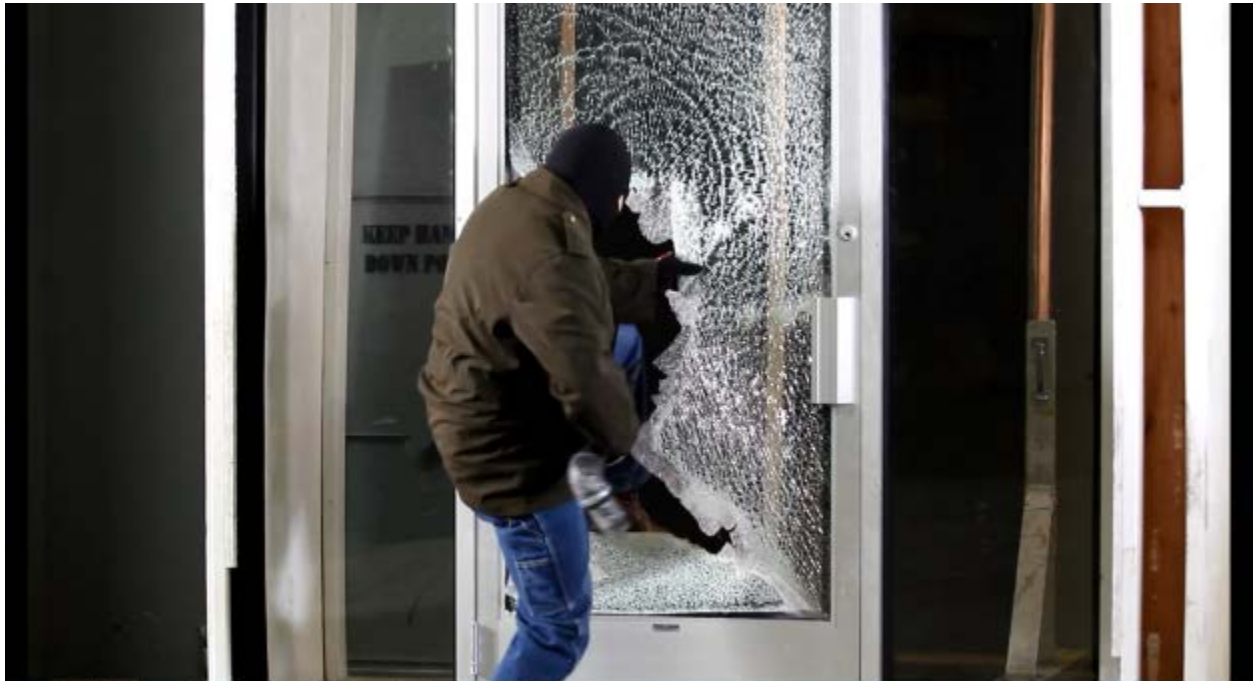
Photo No. 12

9.6 Result: A total of 91 seconds elapsed before the attacker was able to gain access through door entryway system

Test #5: Semi-automatic rifle attack, access gained after 70 impacts and 91 seconds.
