BREAK and ENTRY PERFORMANCE TEST REPORT

Report No.: C7770.02-201-44

3M COMPANY
St. Paul, Minnesota

PRODUCT TYPE: Safety and Security Window Film
SERIES/MODEL: 3M – 14 mil Safety and Security Film

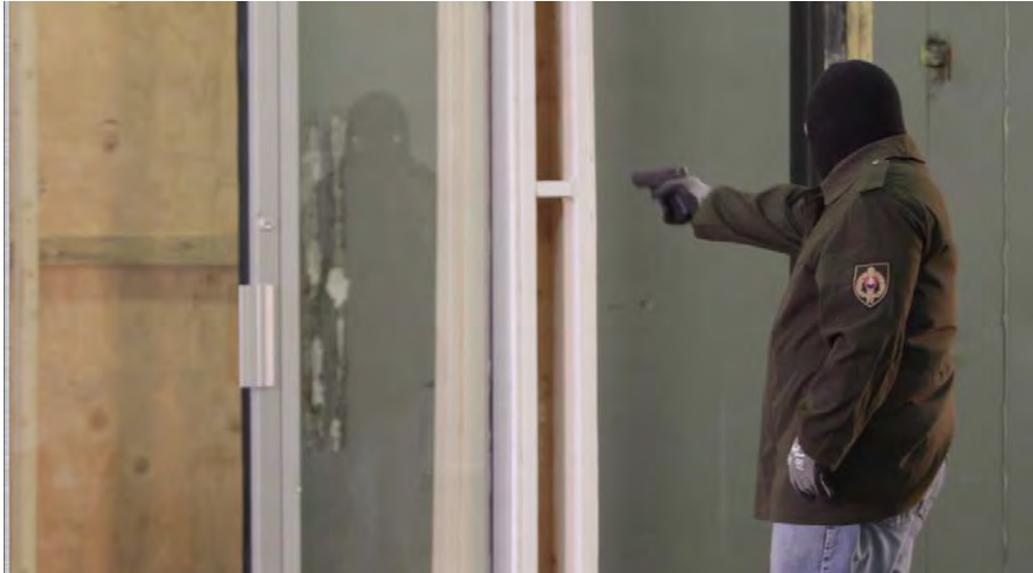
Photo No. 1

Test #1: Handgun attack, no security film.

5.0 Test #1: Handgun attack, no security film

5.3 Film Attachment: No film was utilized

5.4 Area of Attack: Sidelite

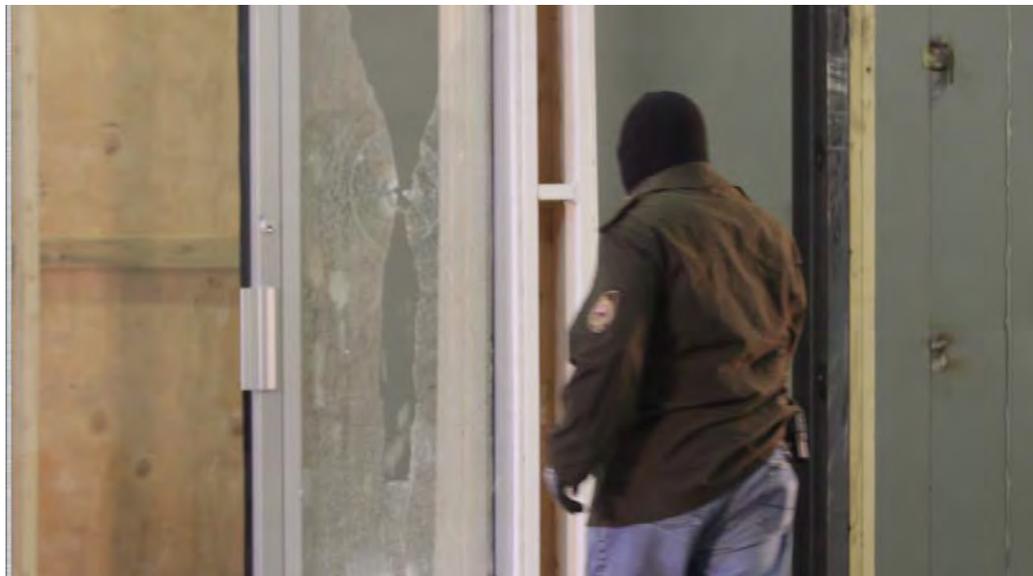
Photo No. 2

Test #1: Handgun attack, no security film. After 1 gun shot.

Note 1: The handgun utilized was a Glock Model 23 in .40 S&W. The ammunition utilized was full metal jacketed.

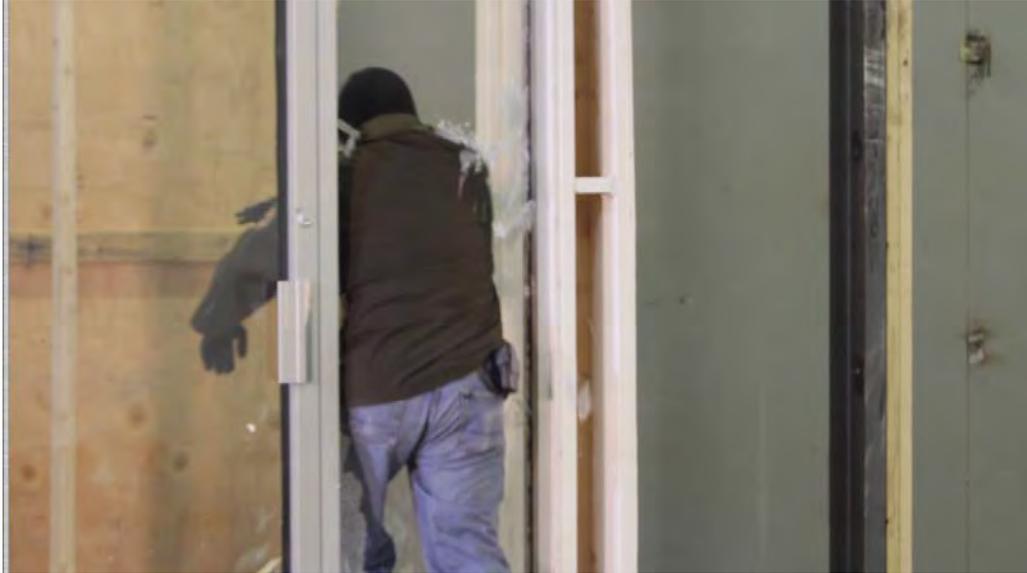
Photo No. 3

Test #1: Handgun attack, no security film. Access after 3 seconds.

<u>Method of Attack</u>	<u>Number of Impacts/Shots</u>	<u>Time Elapsed (Seconds)</u>	<u>Note</u>
Gunshots	1	0:00:03	1

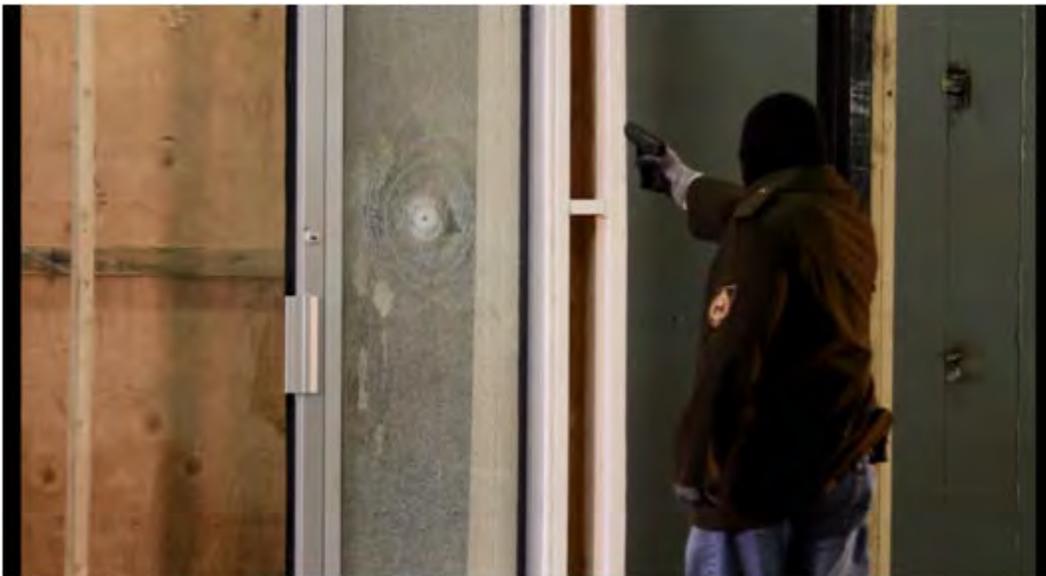
Photo No. 4

Test #2: Handgun attack, 3M Safety S140 (14-mil Security Film).

6.0 Test #2: Handgun attack, 3M 14-mil Safety and Security Window Film (Safety S140)

6.3 Film Attachment: 3M Impact Protection Profile flexible-mechanical attachment

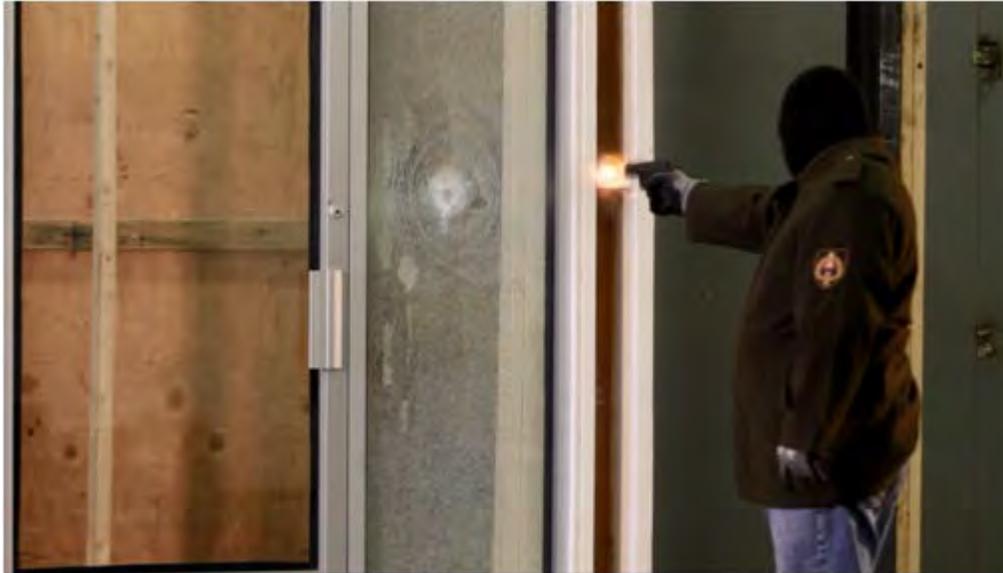
Photo No. 5

Test #2: Handgun attack, 3M Safety S140 (14-mil Security Film). After 4 gun shots.

Note 1: The handgun utilized was a Glock Model 23 in .40 S&W. The ammunition utilized was full metal jacket.

Note 2: Attempted attack with upper body after first shot.

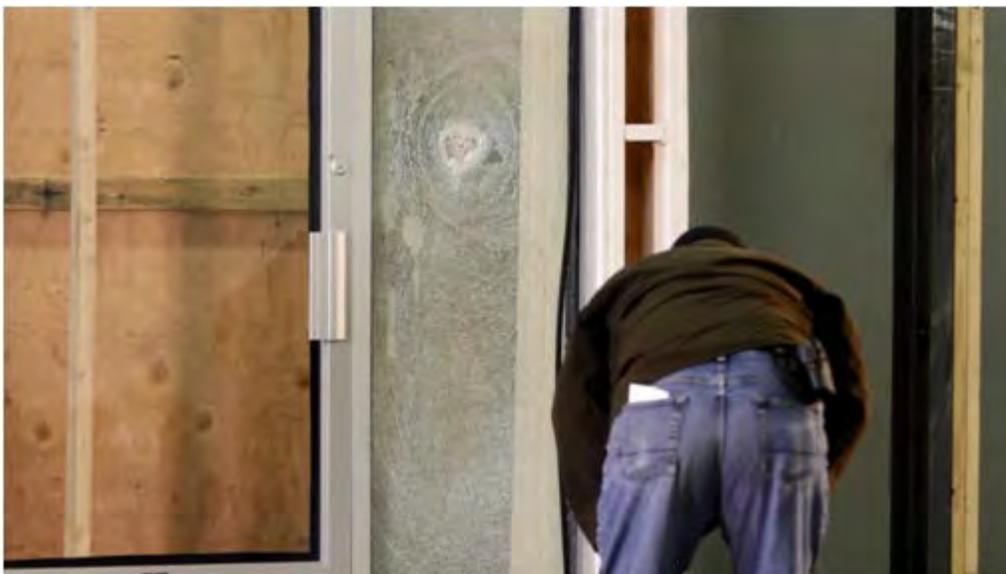
Photo No. 6

Test #2: Handgun attack, 3M Safety S140 (14-mil Security Film). After 4 gun shots, 35 upper body attacks, 39 kicking attempts. Total time elapsed was 95 seconds.

Note 3: Upper body attack defined as a discrete attempt to push, pull, punch, rip or tear the glazing with hands, fists, or elbow.

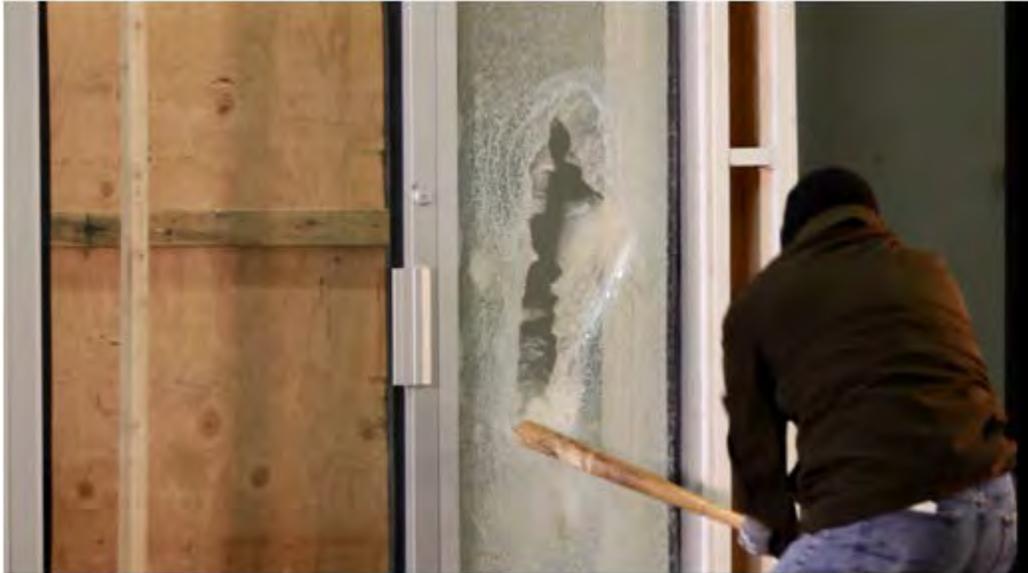
Photo No. 7

Test #2: Handgun attack, 3M Safety S140 (14-mil Security Film). Attack with baseball bat.

<u>Method of Attack</u>	<u>Number of Impacts/Shots</u>	<u>Time Elapsed (Seconds)</u>	<u>Note</u>
Gunshots	4	0:00:03	1, 2
Upper Body Attack	3	0:00:01	3
Kicking	25	0:00:34	
Upper Body Attack	9	0:00:07	3
Kicking	3	0:00:05	
Upper Body Attack	7	0:00:04	3
Kicking	4	0:00:10	
Upper Body Attack	5	0:00:04	3
Kicking	7	0:00:13	
Upper Body Attack	11	0:00:09	3
Baseball bat	24	0:00:27	
Totals from above:			
Gunshots	4	0:00:08	1
Upper Body Attack	35	0:00:25	3
Kicking	39	0:01:02	
Baseball bat	24	0:00:27	
Total:	102	0:02:02

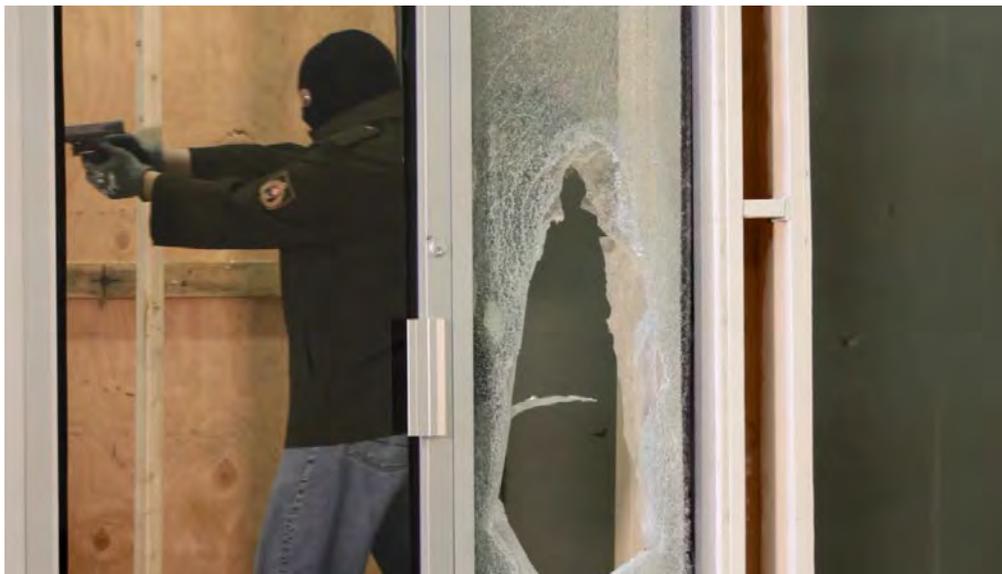
Photo No. 8

Test #2: Handgun attack, 3M Safety S140 (14-mil Security Film). Access after 4 gun shots, 35 upper body attacks, 39 kicking attempts, 24 impacts with baseball bat. Total time elapsed was 122 seconds.

6.6 Result: A total of 2 minutes, 2 seconds elapsed before the attacker was able to gain access through door entryway system.

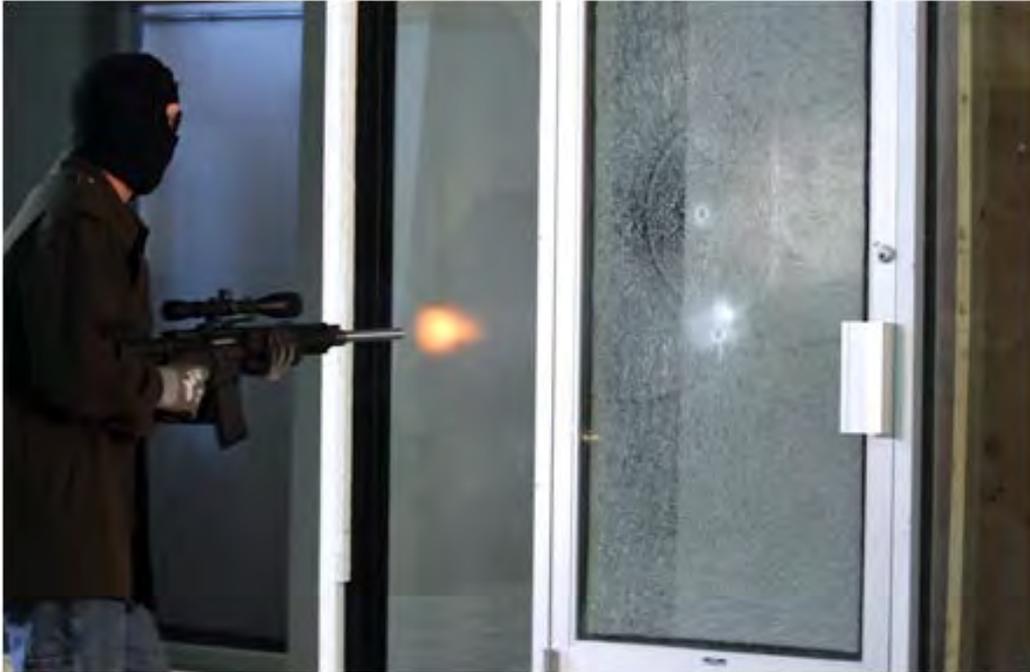
Photo No. 9

Test #3: Semi-automatic rifle attack, 3M Safety S140 (14-mil Security Film). After 4 gunshots.

7.0 Test #3: Semi-Automatic Rifle attack, 3M 14-mil Safety and Security Window Film (Safety S140)

Note 1: The rifle utilized was a Rock River Arms AR-15 in .223 caliber. The ammunition utilized was ballistic tipped.

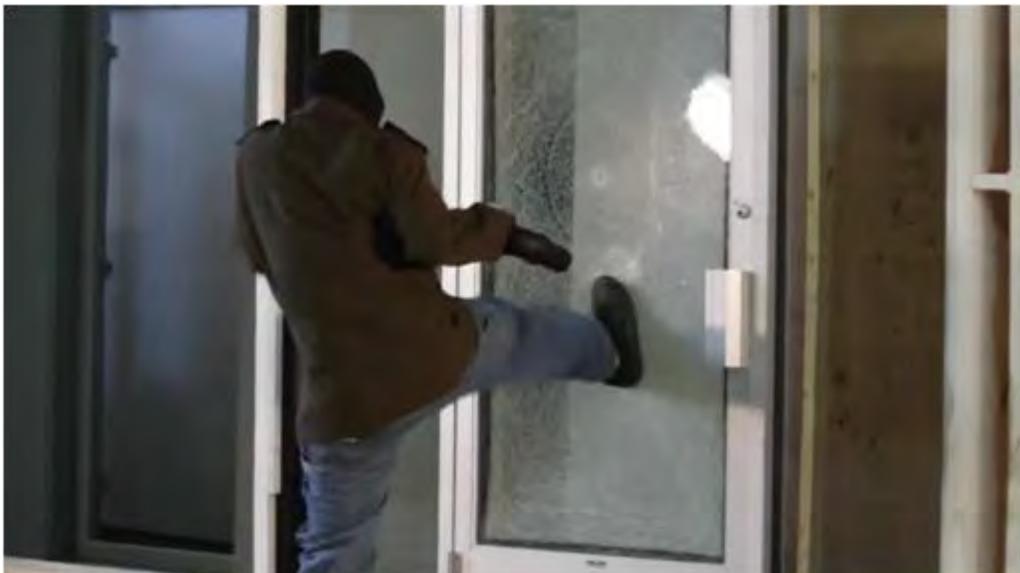
Photo No. 10

Test #3: Semi-automatic rifle attack, 3M Safety S140 (14-mil Security Film). Kick attempts after 4 gunshots.

Note 2: Attempted pushing glazing after first shot.

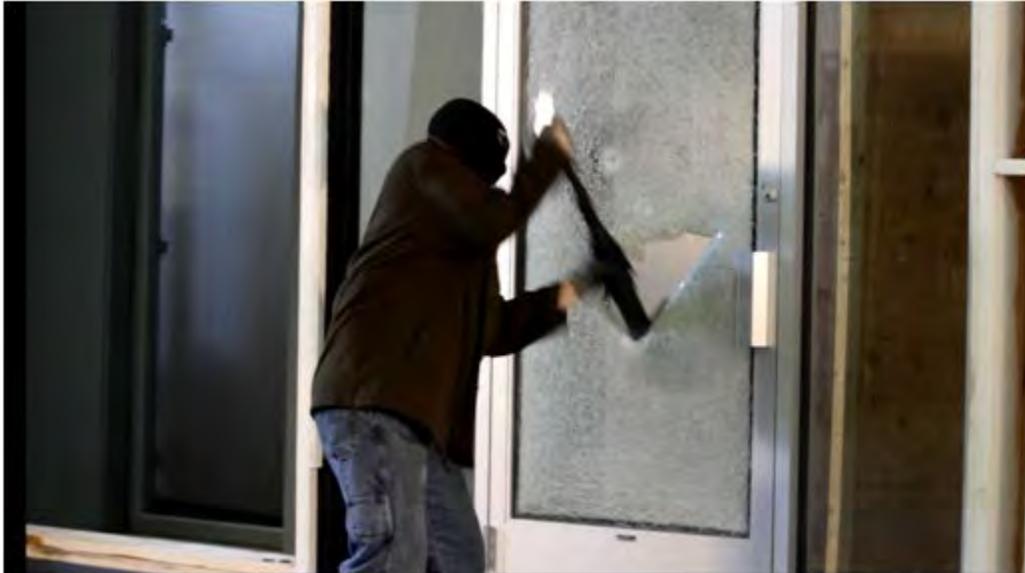
Photo No. 11

**Test #3: Semi-automatic rifle attack, 3M Safety S140 (14-mil Security Film).
Simulated rifle attack, using 9-lb steel pipe.**

Note 4: Simulated rifle attack consisted of direct impact with a nine pound galvanized steel pipe in the shape of a rifle.

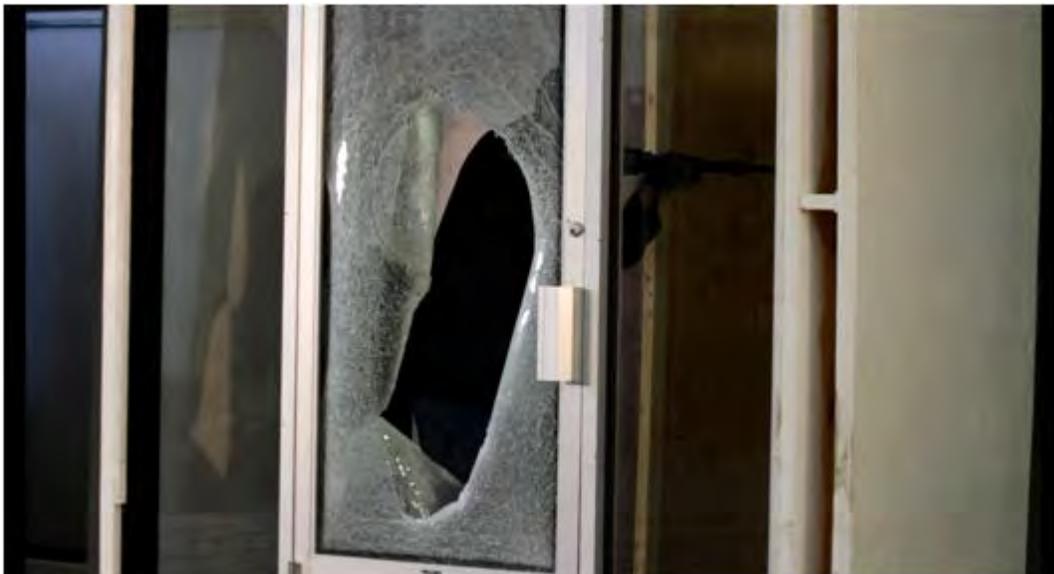
Photo No. 12

**Test #3: Semi-automatic rifle, 3M Safety S140 (14-mil Security Film). Access after 4
gun shots, 11 upper body attacks, 42 kicking attempts, 24 impacts with 9-lb
steel pipe. Total time elapsed was 106 seconds.**

7.6 Result: A total of 1 minute, 46 seconds elapsed before the attacker was able to gain access through door entryway system.

<u>Method of Attack</u>	<u>Number of Impacts/Shots</u>	<u>Time Elapsed (Seconds)</u>	<u>Note</u>
Gunshots	4	0:00:06	1, 2
Upper Body Attack	8	0:00:08	3
Kicking	42	0:00:59	
Simulated rifle attack	24	0:00:27	4
Upper Body Attack	3	0:00:06	3
<u>Totals from above:</u>			
Gunshots	4	0:00:06	1
Upper Body Attack	11	0:00:14	3
Kicking	42	0:00:59	
Simulated rifle attack	24	0:00:27	4
Total:	81	0:01:46
