3M COMPANY

Cover Page: 1 page
Report Body: 21 pages
Test Facility: 1 page
Pressure Time Plots: 28 pages
Photographs: 21 pages
Drawings: 12 pages

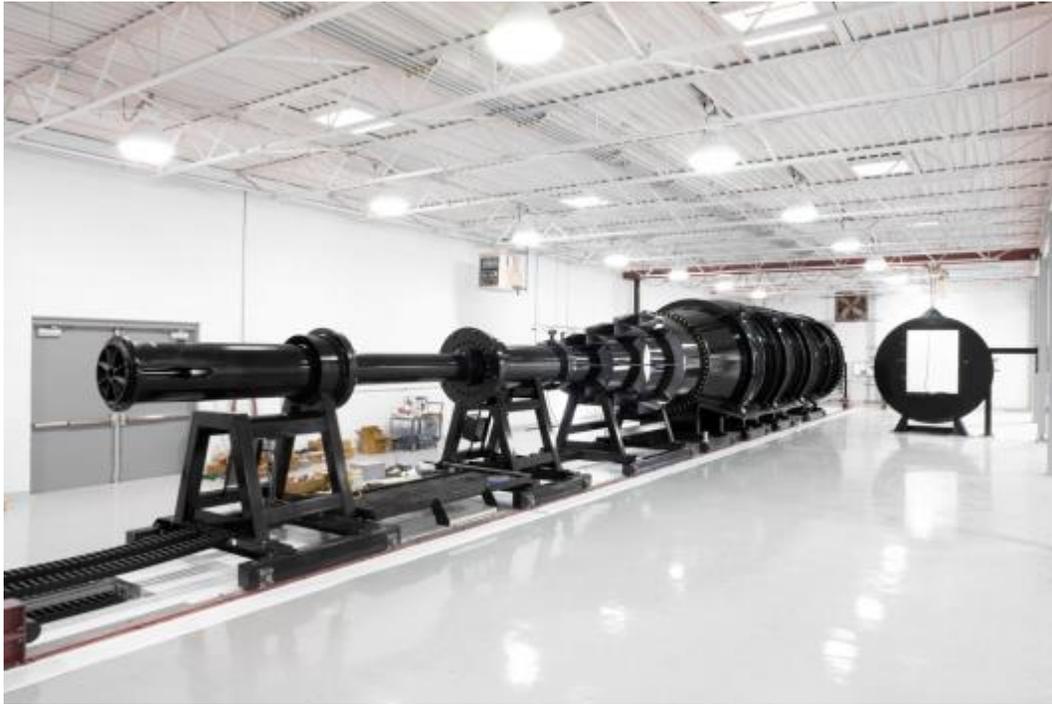
Figure #1
Shock Tube and Test Facility

3.6 Test Facility: Intertek-ATI's shock tube is housed in a 10,000 square foot state-of-the-art test facility located in York, Pennsylvania. Blast loadings are produced on the specimen to simulate the effects of a high explosive charge at a specified standoff distance. Shock waves are generated by the sudden rupturing of a thin aluminum membrane. The shock wave expands as it travels down the tube, and impacts the target with a specific positive pressure and impulse. A photograph of the shock tube is provided in Figure #1 of Appendix A.

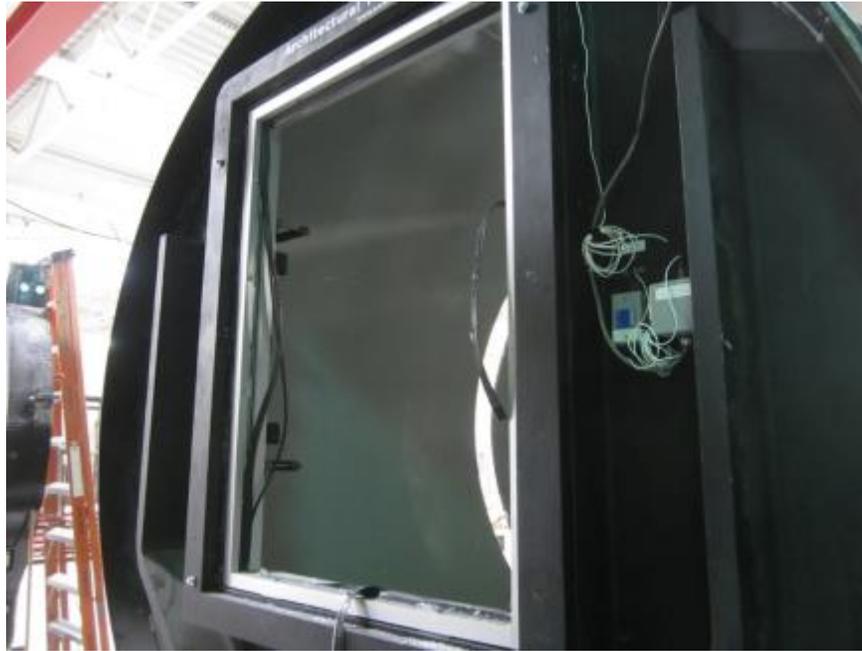
Photo No. 5
Post-test Specimen #2, Interior

Glazing Response	
Lite	Fractured
Glazing Pullout Length and Location	Entire lite deglazed
Glazing Tearing	N/A

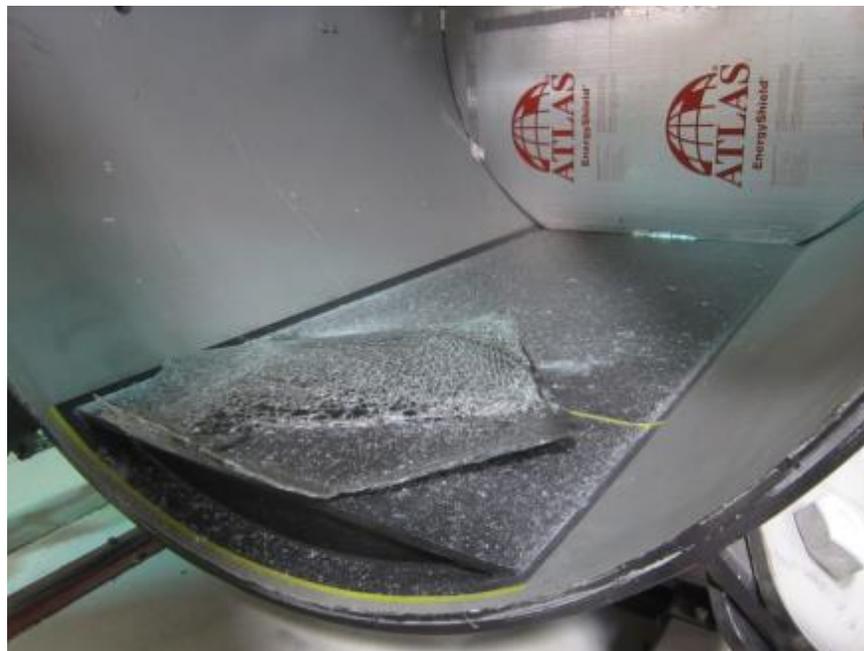
Photo No. 6
Post-test Specimen #2, Witness Chamber

Witness Chamber Results
Glass completely deglazed and landed on witness chamber floor near sill. Large quantities of fragments were on the witness chamber floor with 3 fragment indents and 1 sliver perforation on the witness panel.
