**ASTM F1642-04 / GSA TS01 TEST REPORT**

Fragment Retention Film on 1/4" Single Pane Glass

3M™ Scotchshield™ Ultra S600 Safety and Security Window Film with  
3M™ Impact Protection Profile Film Attachment System

**Report No.:** D8962.01-119-12  
**Test Completion Date:** 07/22/14  
**Report Date:** 10/30/14  
**Test Record Retention Date:** 07/22/18

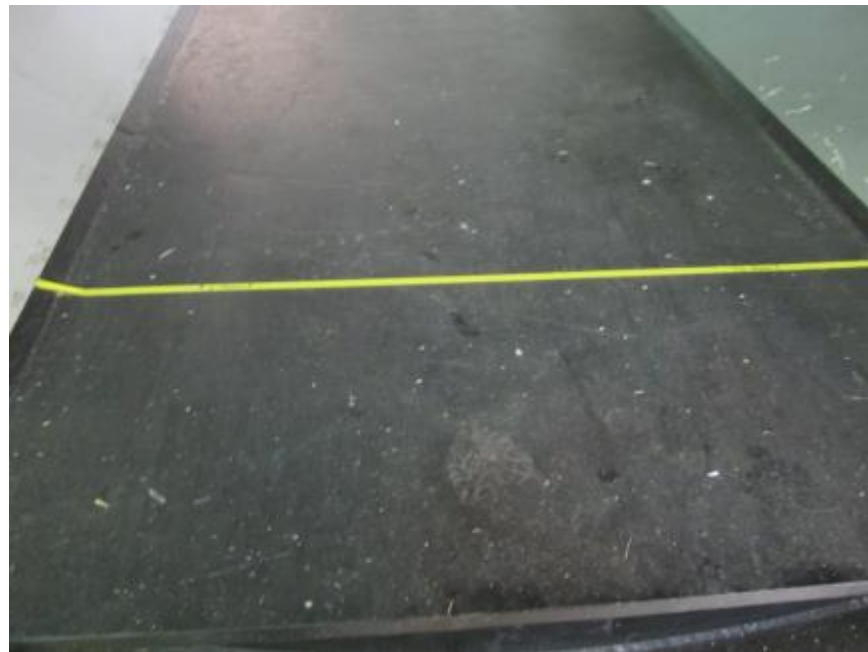
**Photo No. 2**  
**Post-test Specimen #1, Witness Chamber**

Witness Chamber Results
Three fragments were located beyond 1m from the specimen on the witness chamber floor. One fragment indent was located at a height of 27-1/2" on the witness panel.

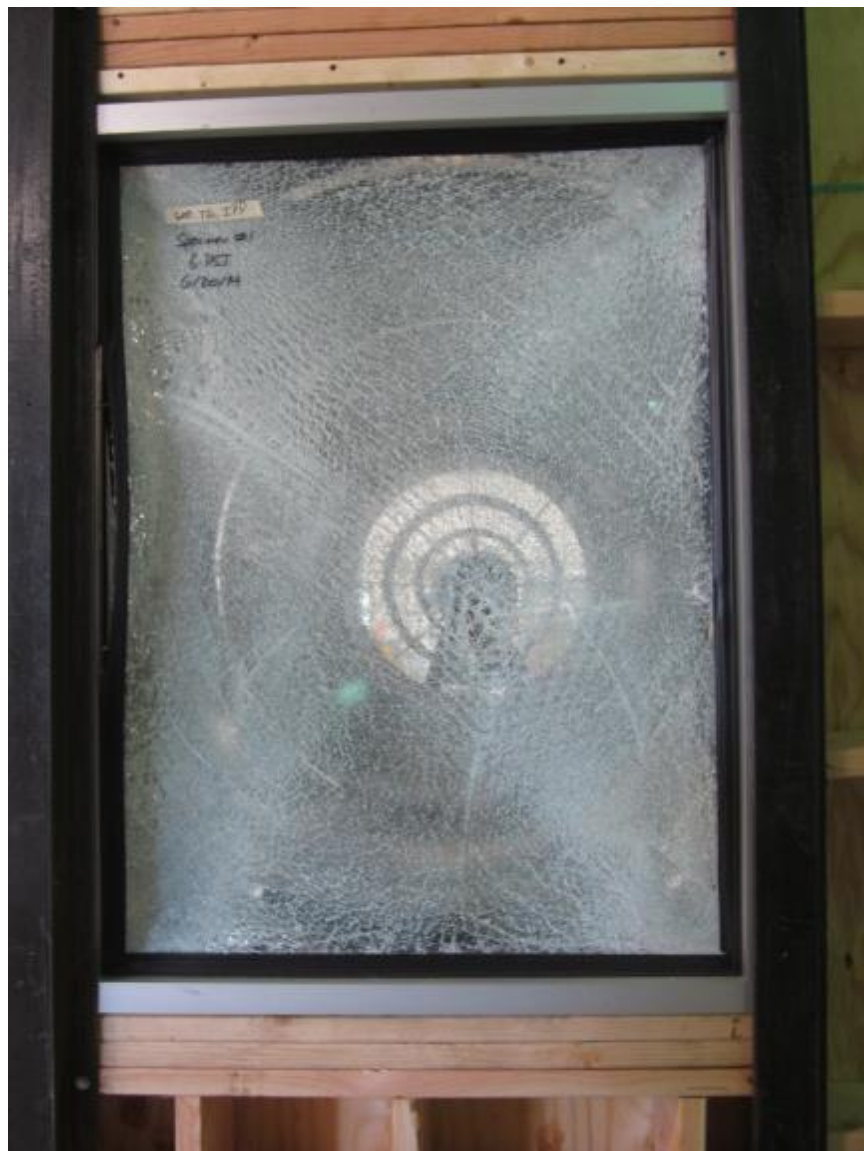
**Photo No. 3**  
**Post-test Specimen #1, Interior**

Glazing Response	
Lite	Fractured
Glazing Pullout Length and Location	20" along jamb
Glazing Tearing	None

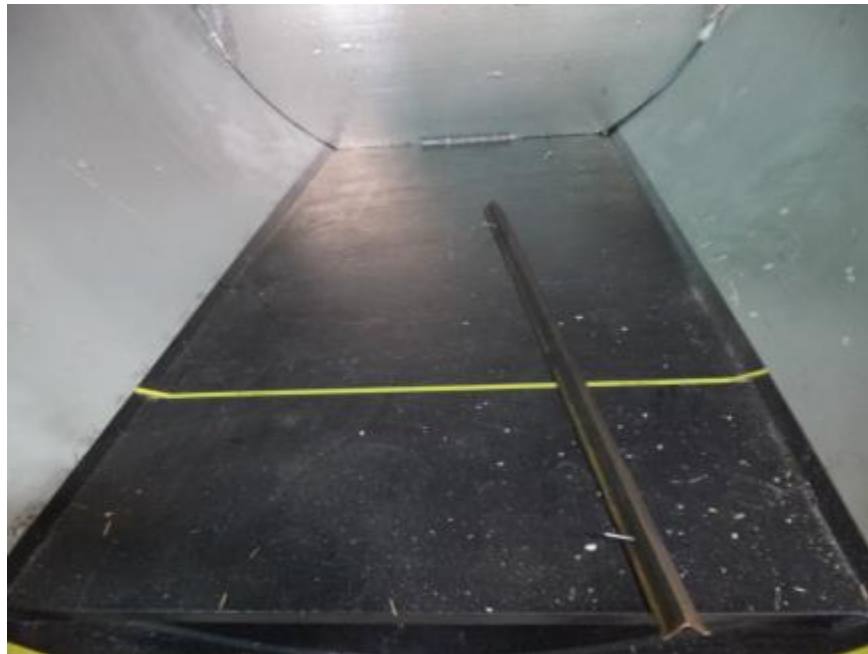
**Photo No. 5**  
**Post-test Specimen #2, Witness Chamber**

Witness Chamber Results	
A dusting of glass was deposited on the witness chamber floor.

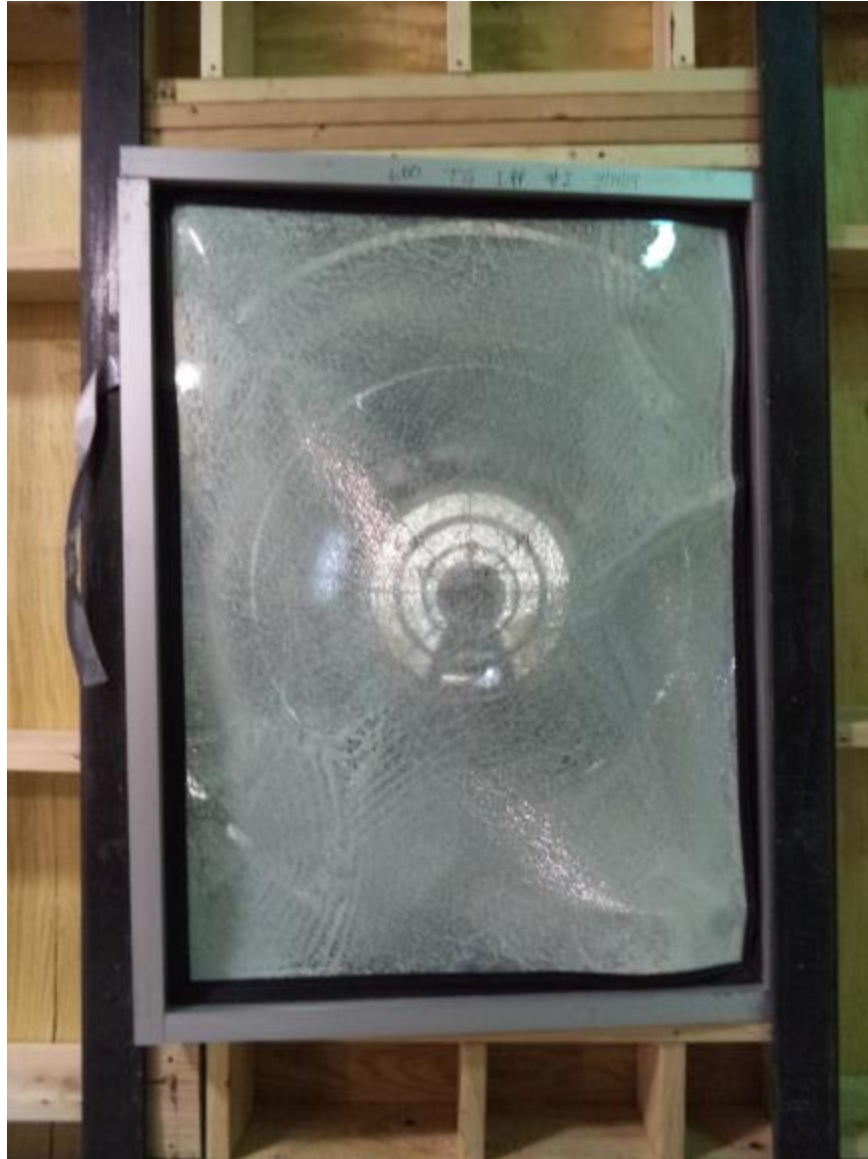
**Photo No. 6**  
Post-test Specimen #2, Interior

Glazing Response	
Exterior Lite	Fractured
Glazing Pullout Length and Location	1" at top left corner
Glazing Tearing	1" at top left corner

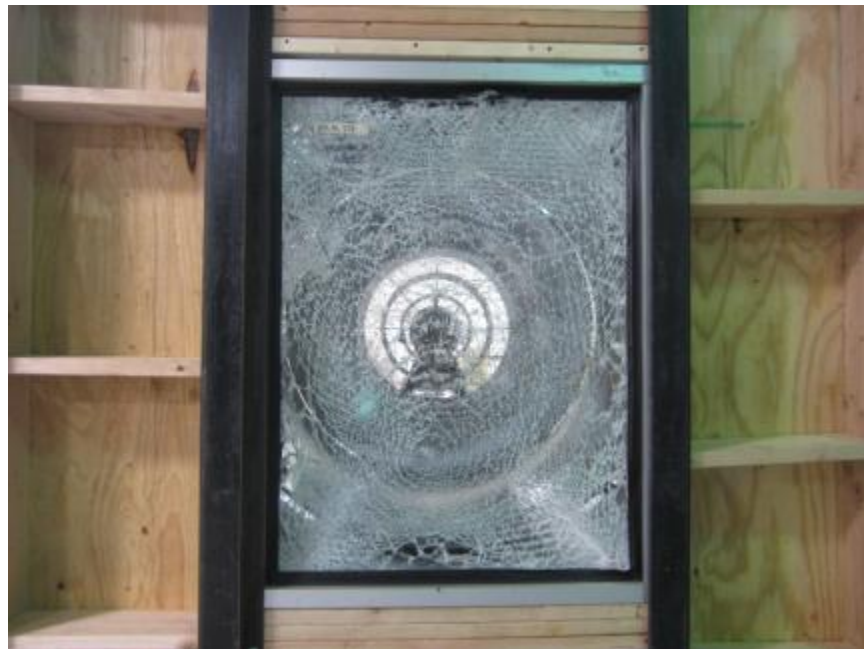
**Photo No. 14**  
**Post-test Specimen #5, Interior**

Glazing Response	
Exterior Lite	Fractured
Glazing Pullout Length and Location	1-1/2" along head
Glazing Tearing	4" at center

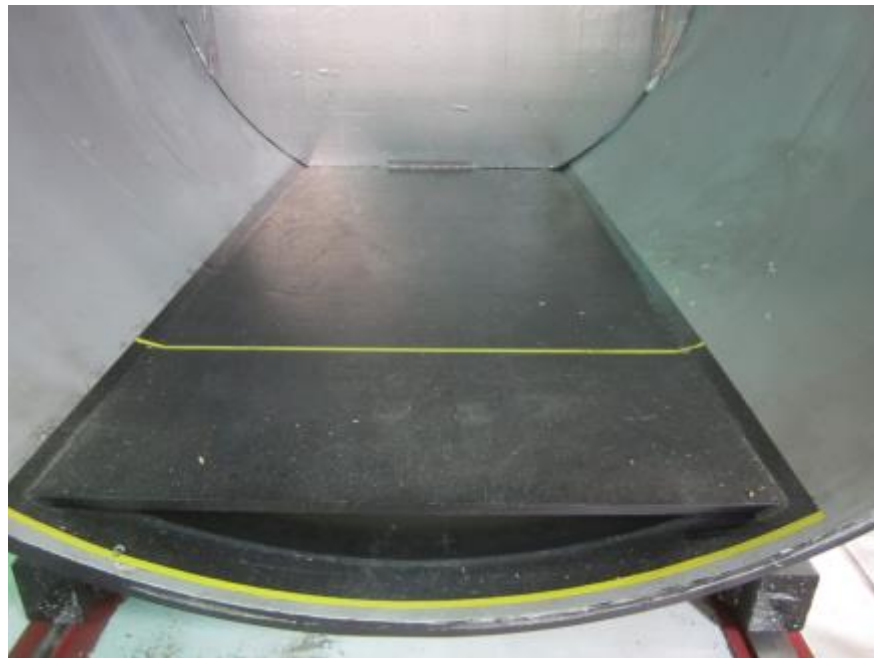
**Photo No. 15**  
**Post-test Specimen #5, Witness Chamber**

Witness Chamber Results
One glazing fragment found on the floor near the sill. Dusting and glazing slivers were present on the floor back to the witness panel.

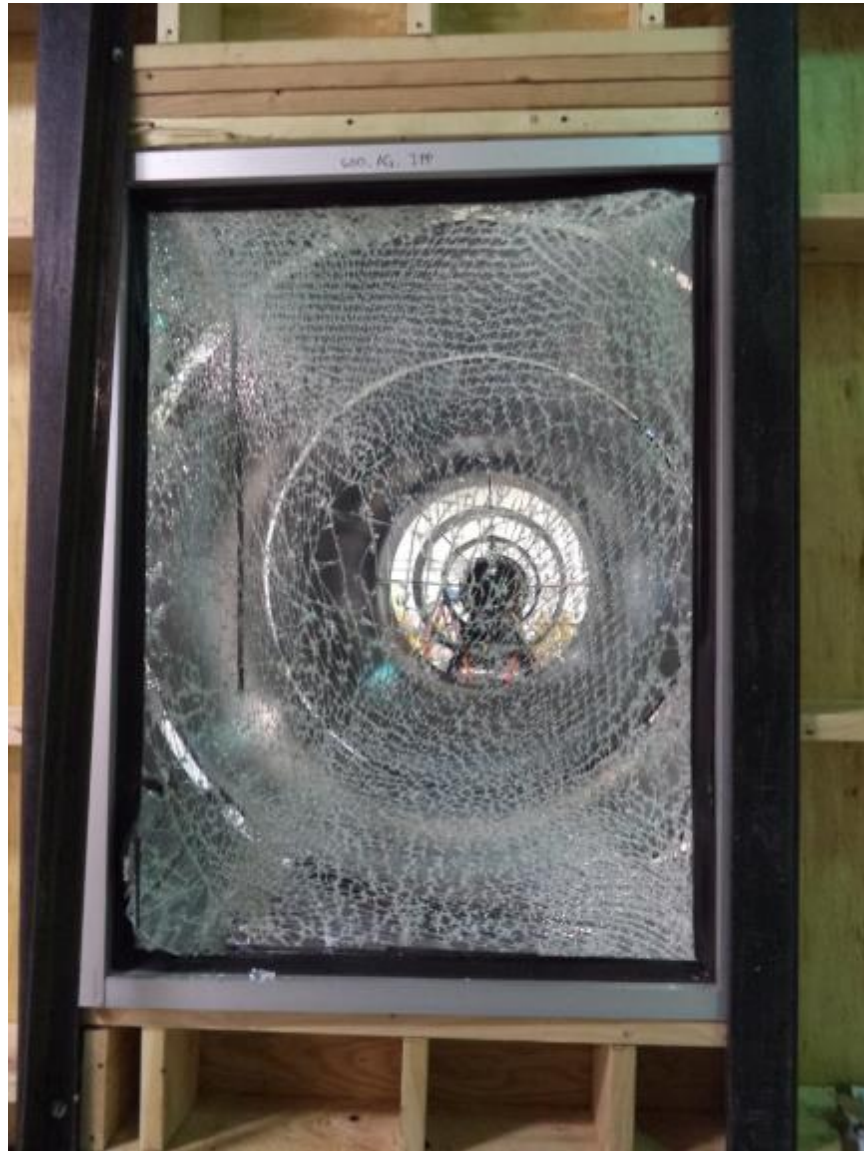
**Photo No. 17**  
**Post-test Specimen #6, Interior**

Glazing Response	
Exterior Lite	Fractured
Glazing Pullout Length and Location	26" along sill, 10" along right jamb, 11" along left jamb
Glazing Tearing	1-3/4" upper right corner, 3" lower left corner

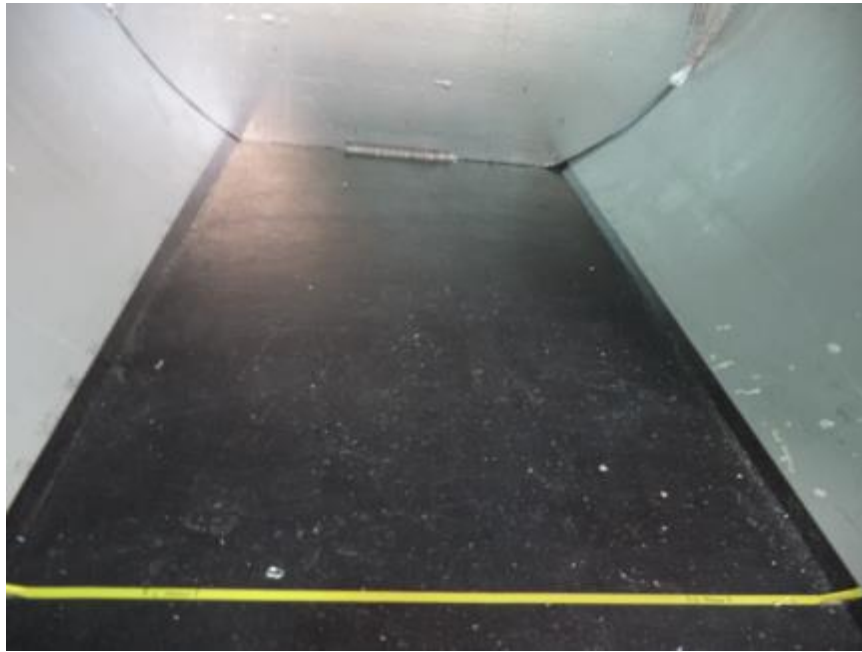
**Photo No. 18**  
**Post-test Specimen #6, Witness Chamber**

Witness Chamber Results
Several glazing fragments were located on the floor beyond 1m (<10" united). One fragment indent was located 3" from the floor on the witness panel.

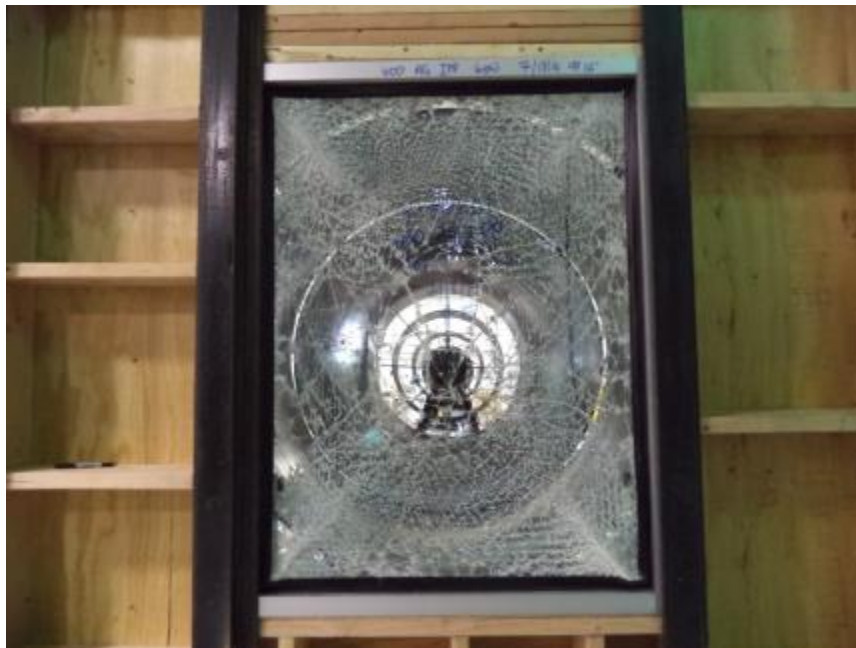
**Photo No. 20**  
**Post-test Specimen #7, Interior**

<b>Glazing Response</b>	
Exterior Lite	Fractured
Glazing Pullout Length and Location	None
Glazing Tearing	1/2" at the lower left corner, 1/2" at the lower right corner

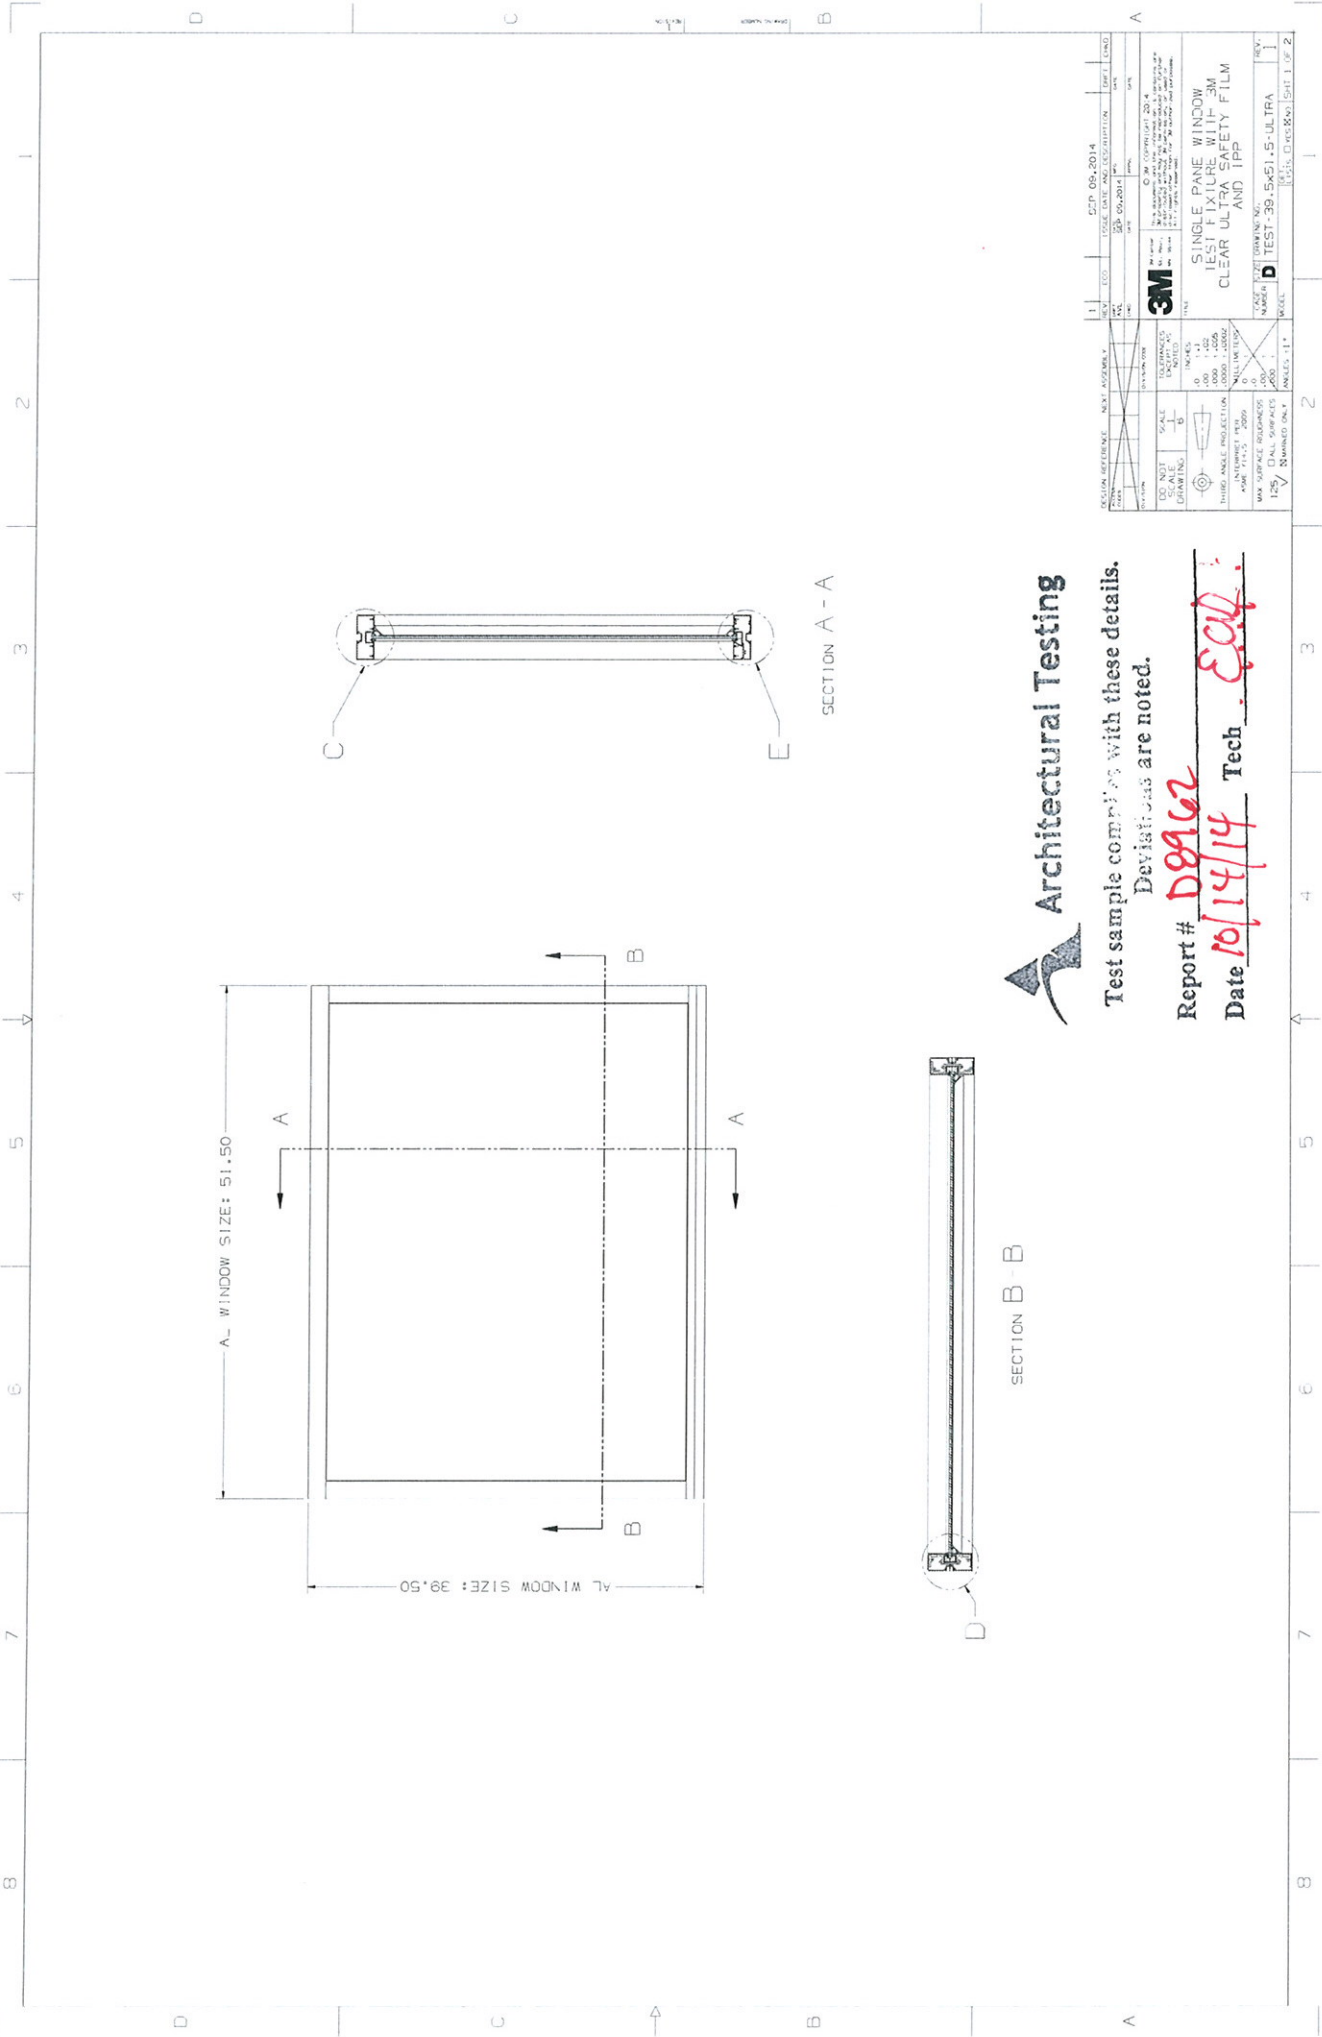
3M  
 SINGLE PANE WINDOW  
 TEST FIXTURE WITH 3M  
 CLEAR ULTRA SAFETY FILM  
 AND IPP

SECTION A - A

SECTION B - B

**3.7 Drawing Reference:** The test specimen drawings have been reviewed by Architectural Testing and are representative of the test specimens reported herein. Test specimen construction was verified by Architectural Testing per the drawings located in Appendix D. Any deviations are documented herein or on the drawings.

**5.3 Glazing:** All specimens utilized 1/4" thick clear glass with a 6 mil micro-layered safety and security film adhered to the interior surface of the glass. The glass was channel glazed and secured at the exterior sill using extruded aluminum glazing stops. The glass was set against a kerf-mounted rubber gasket with a 1/2" glazing bite. The filmed glass was adhesively anchored to the interior side of the frame using 3M™ Impact Protection Profile (IPP), a flexible-mechanical rubber gasket type film attachment system (Reference Drawing Test-39.5 x 51.5-Ultra).
