ASTM F1642-04 / GSA TS01 TEST REPORT

Report No.: D8934.02-119-12

Fragment Retention Film on 1" Double Pane Glass with Film Attachment System

3M™ Scotchshield™ Ultra S800 Safety and Security Window Film
with
3M™ Impact Protection Profile Film Attachment System
or
3M™ Impact Protection Adhesive Film Attachment System

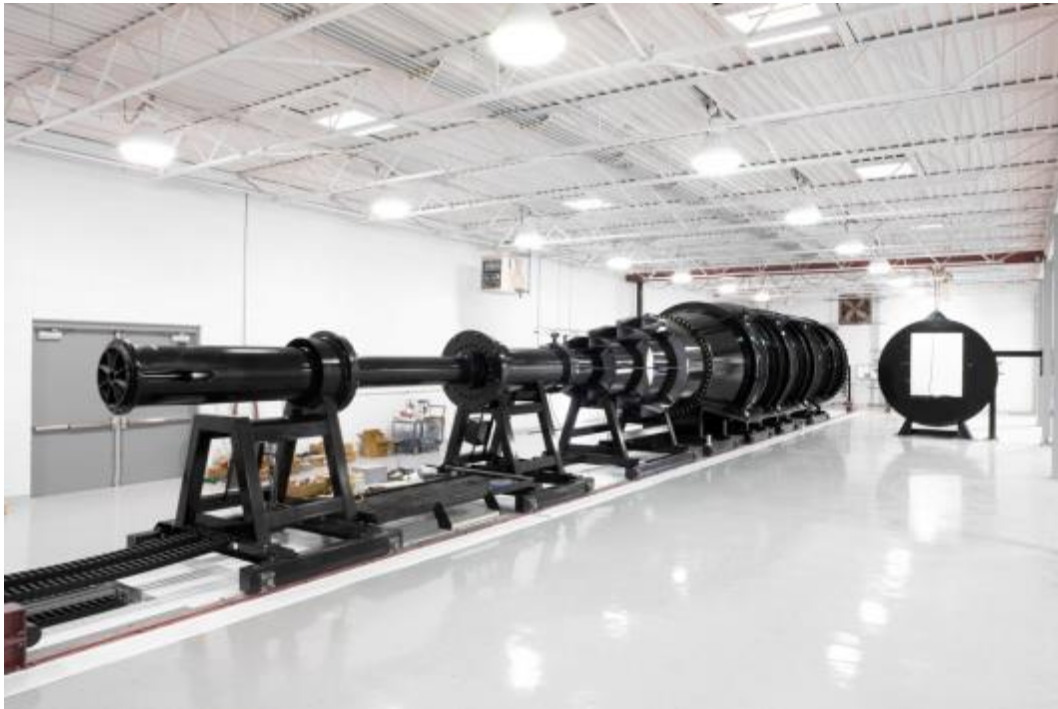
Figure #1
Shock Tube and Test Facility

3.5 Test Facility: Architectural Testing, Inc.'s shock tube is housed in a 10,000 square foot state-of-the-art test facility located in York, Pennsylvania. Blast loadings are produced on the specimen to simulate the effects of a high explosive charge at a specified standoff distance. Shock waves are generated by the sudden rupturing of a thin aluminum membrane. The shock wave expands as it travels down the tube, and impacts the target with a specific positive pressure and impulse. A photograph of the shock tube is provided in Figure #1 of Appendix A.

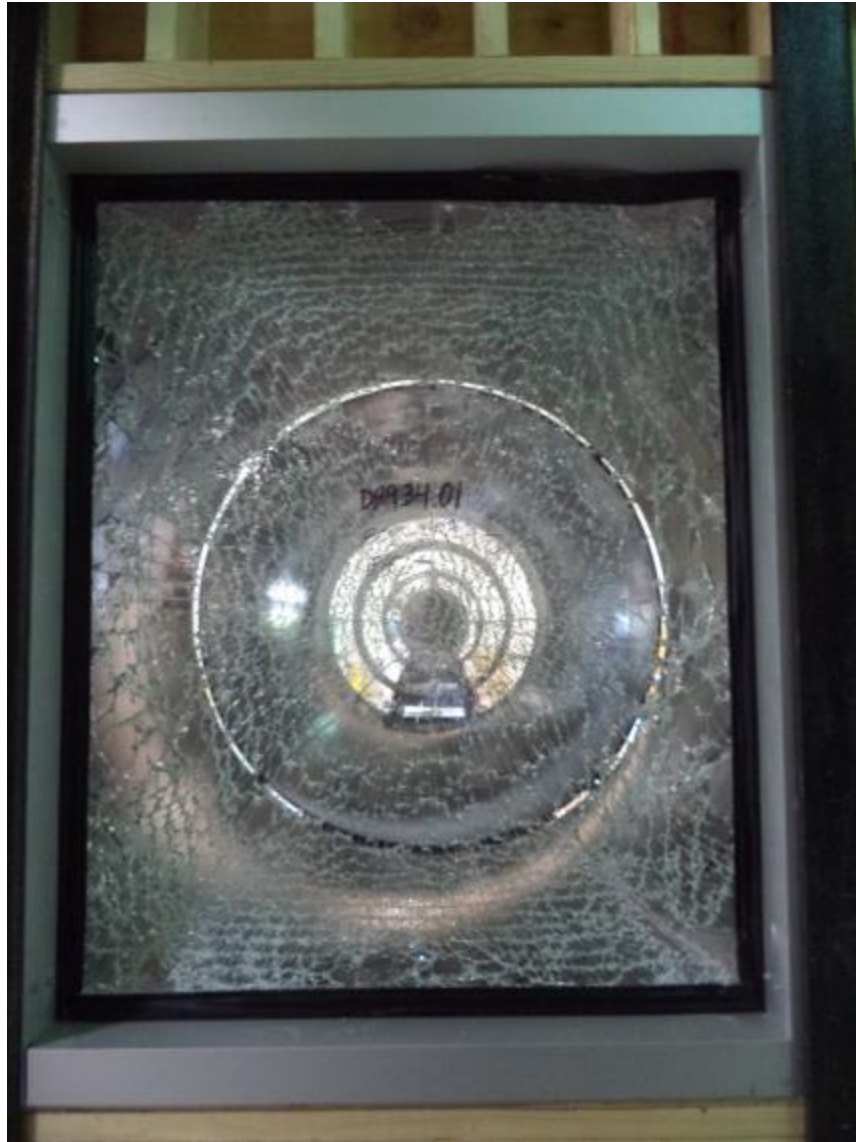
Glazing Response	
Exterior Lite	Shattered
Interior Lite	Fractured
Glazing Pullout Length and Location	12-1/2" along head
Glazing Tearing	1" lower left corner

Photo No. 2
Post-test Specimen #1, Interior

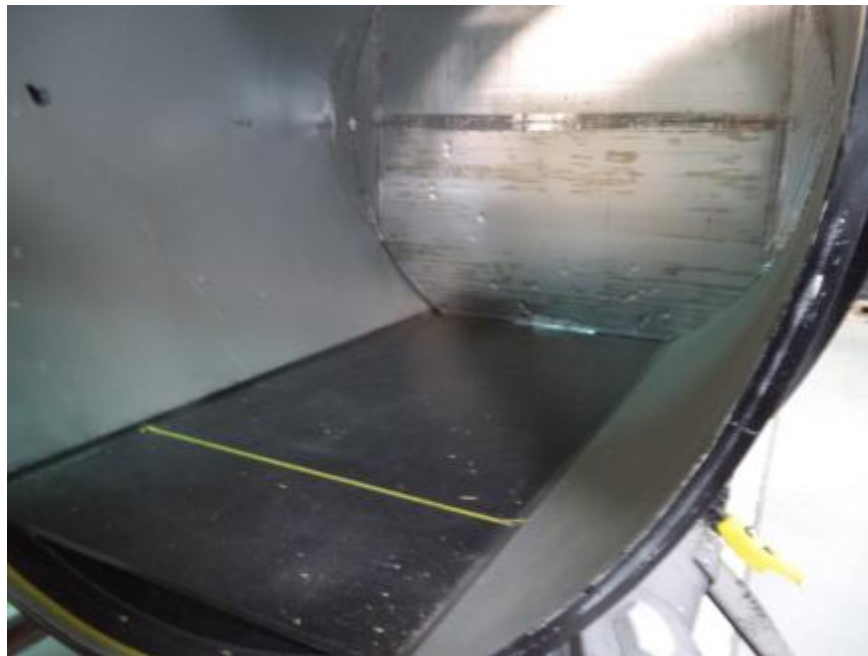
Witness Chamber Results
A dusting of glass was deposited on the witness chamber floor.

Photo No. 3
Post-test Specimen #1, Witness Chamber

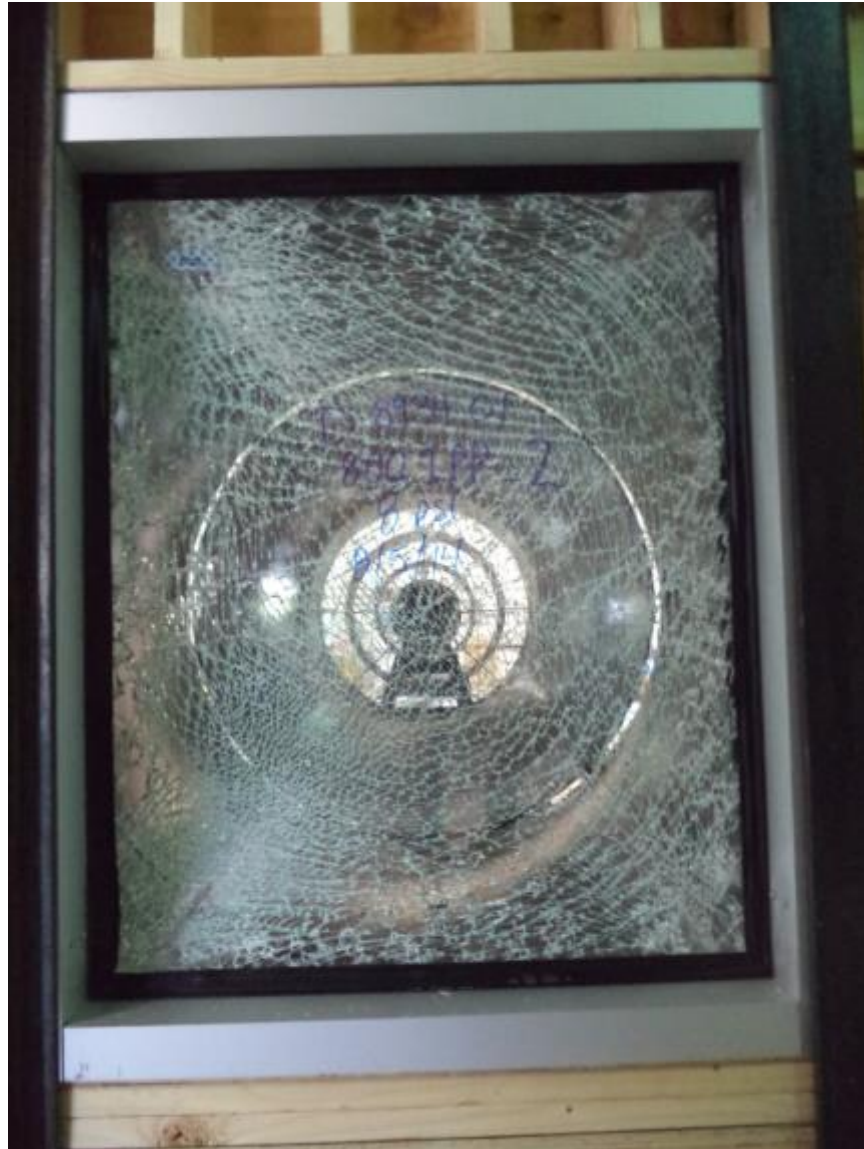
Glazing Response	
Exterior Lite	Shattered
Interior Lite	Fractured
Glazing Pullout Length and Location	6" at lower left
Glazing Tearing	None

Photo No. 5
Post-test Specimen #2, Interior

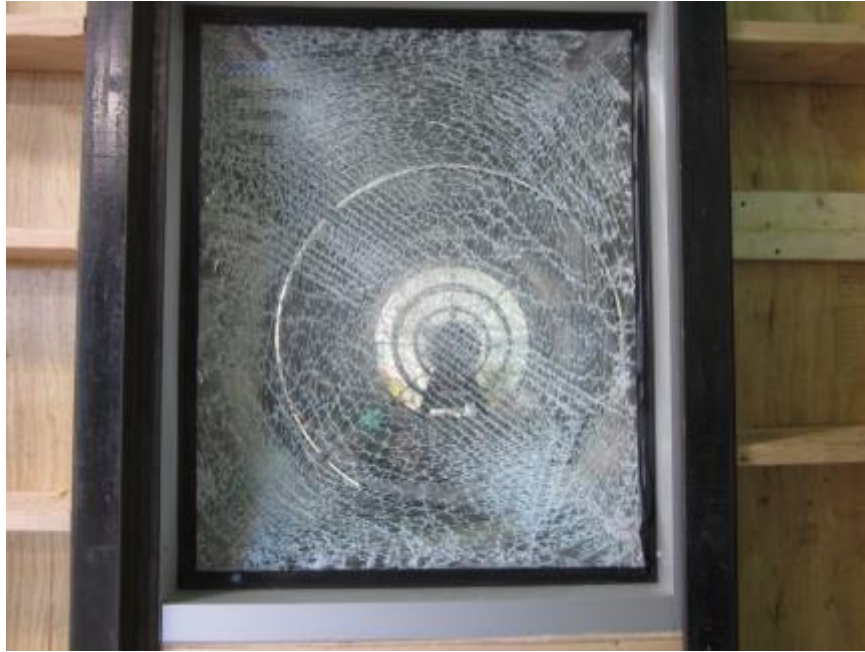
Glazing Response	
Exterior Lite	Shattered
Interior Lite	Fractured
Glazing Pullout Length and Location	None
Glazing Tearing	None

Photo No. 8
Post-test Specimen #3, Interior

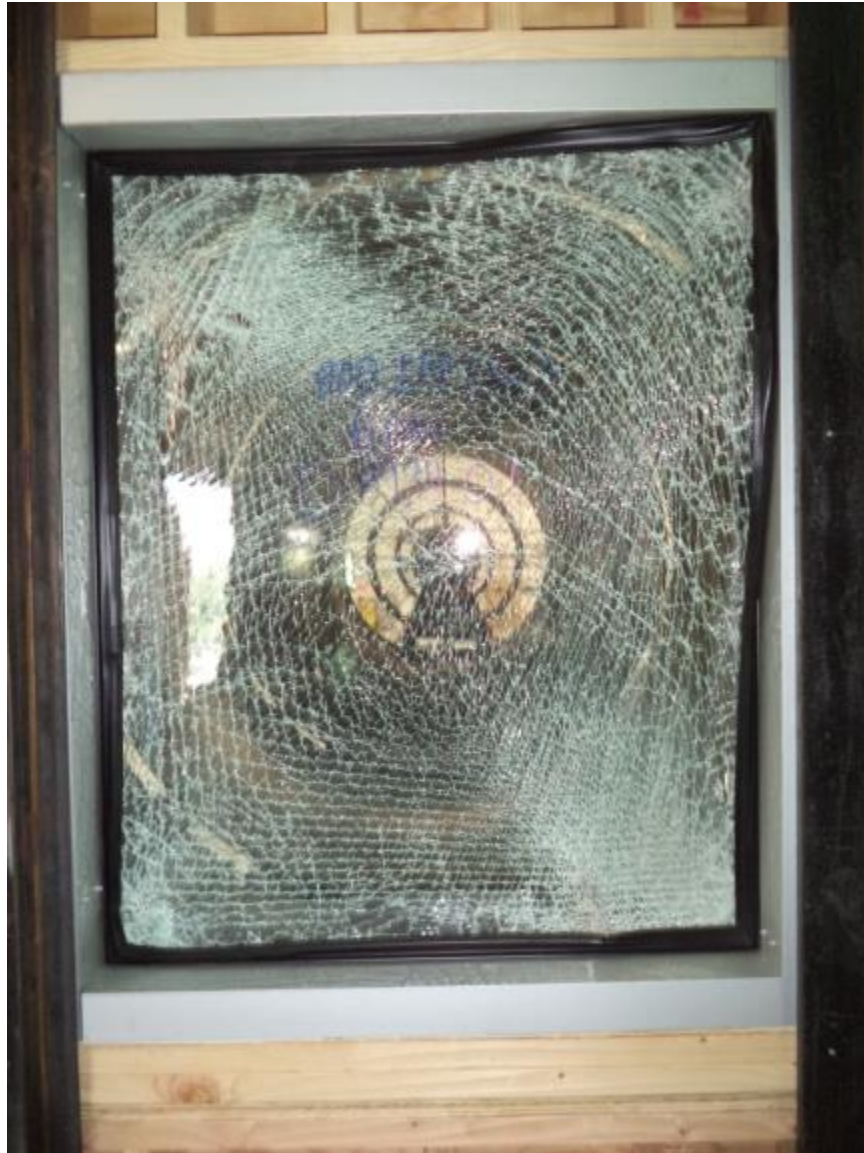
Glazing Response	
Exterior Lite	Shattered
Interior Lite	Fractured
Glazing Pullout Length and Location	24-1/2" along sill and 15" along head
Glazing Tearing	None

Photo No. 11
Post-test Specimen #4, Interior

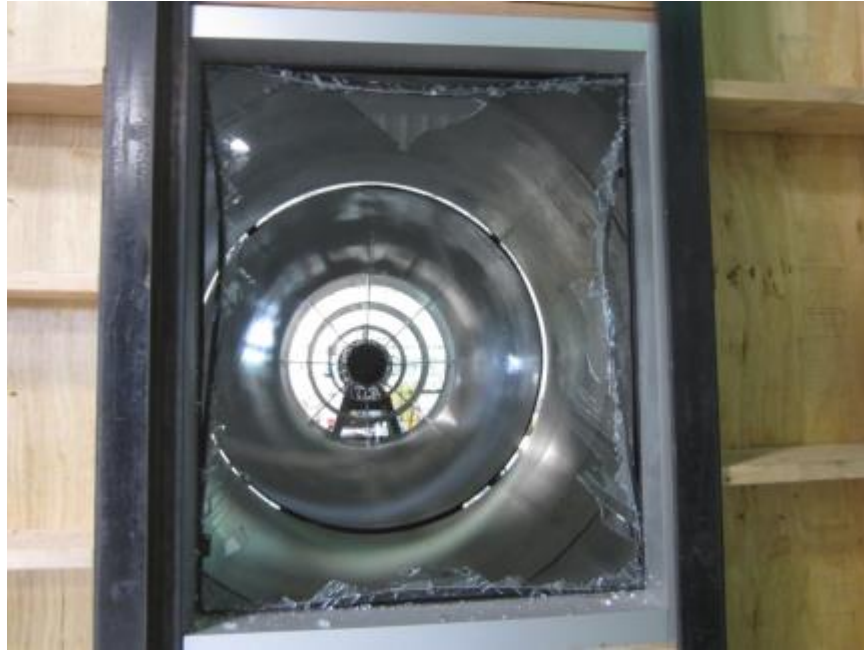
Glazing Response	
Exterior Lite	Shattered
Interior Lite	Fractured and blown out
Glazing Pullout Length and Location	Entire interior lite deglazed
Glazing Tearing	N/A

Photo No. 14
Post-test Specimen #5, Interior

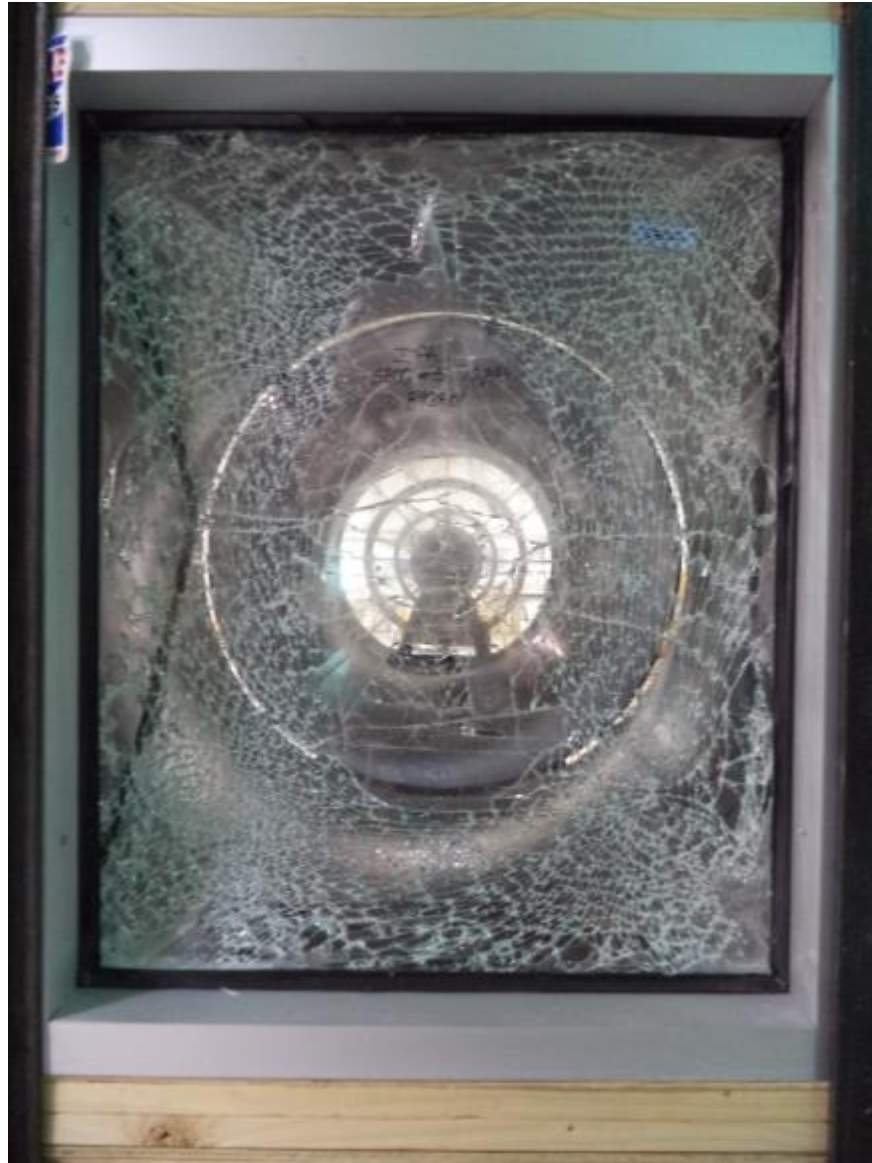
Glazing Response	
Exterior Lite	Shattered
Interior Lite	Fractured
Glazing Pullout Length and Location	None
Glazing Tearing	3/4" long and 1" long

Photo No. 29
Post-test Specimen #10, Interior
